# Technical Memorandum

## Reconnaissance-Level Geologic Hazard Assessment

1107 6<sup>th</sup> Street Southeast  
Bandon, Oregon 97411

May 29, 2022

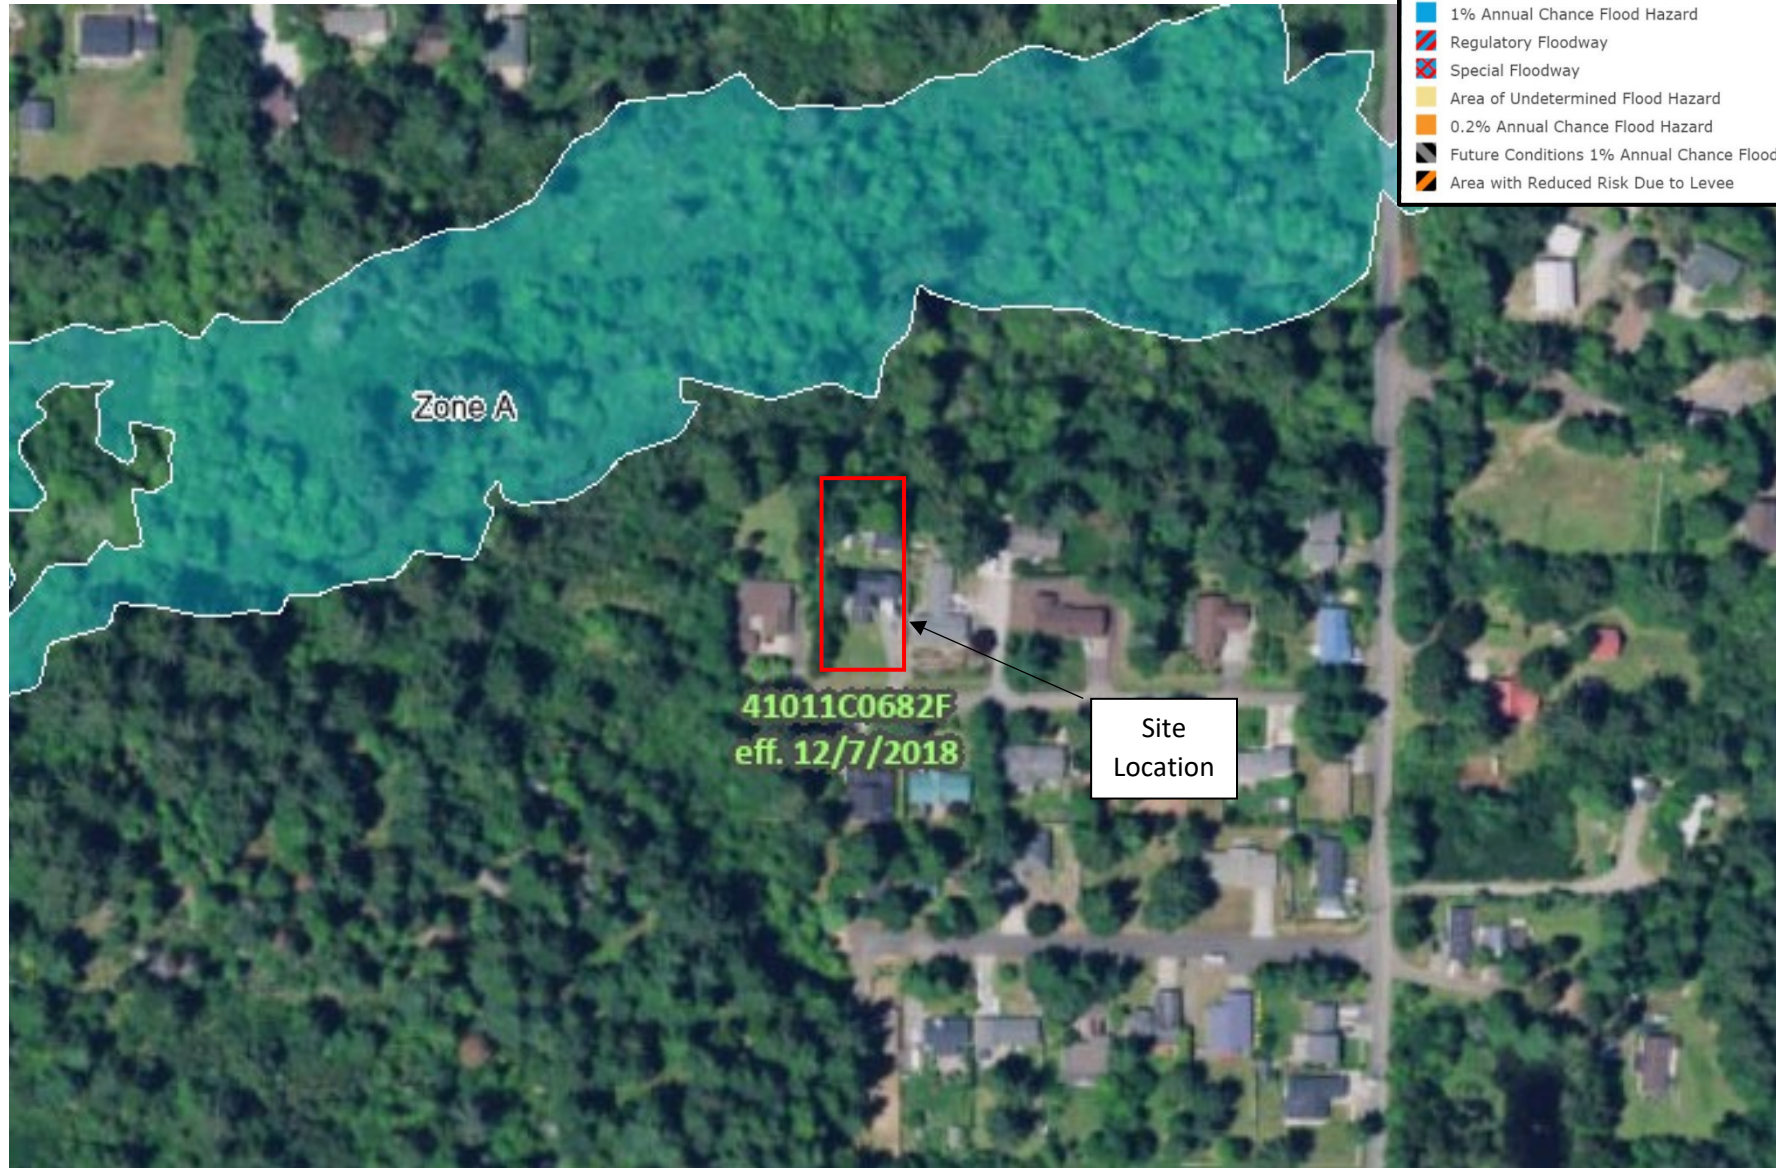
Given the elevation and topographic setting of the subject property, the potential for seasonal, area-wide stream or tidal flood events is very unlikely. A Flood Insurance Rate Map from Federal Emergency Management Agency is attached (Figure 6) showing the entire subject property is outside of the 1% annual chance (100-year) flood plain.

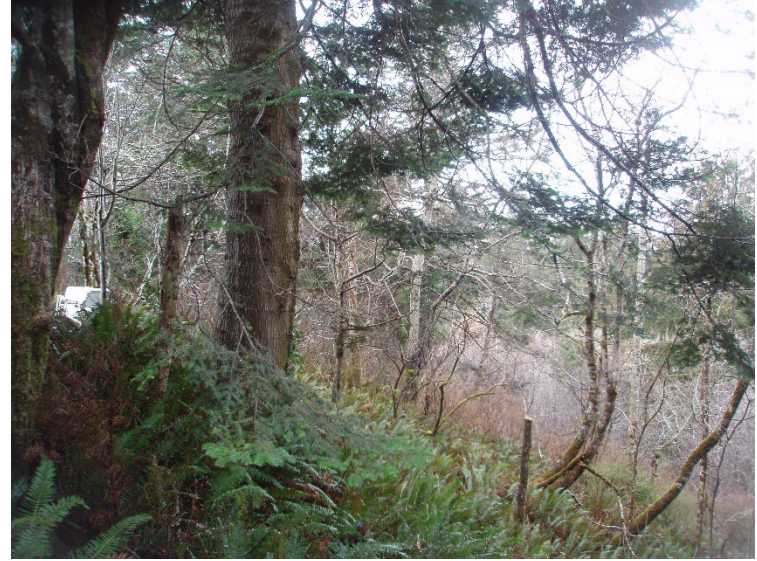
Looking west-northwest from near the northeast corner of the ADU.  
Note bowed trees lower right.

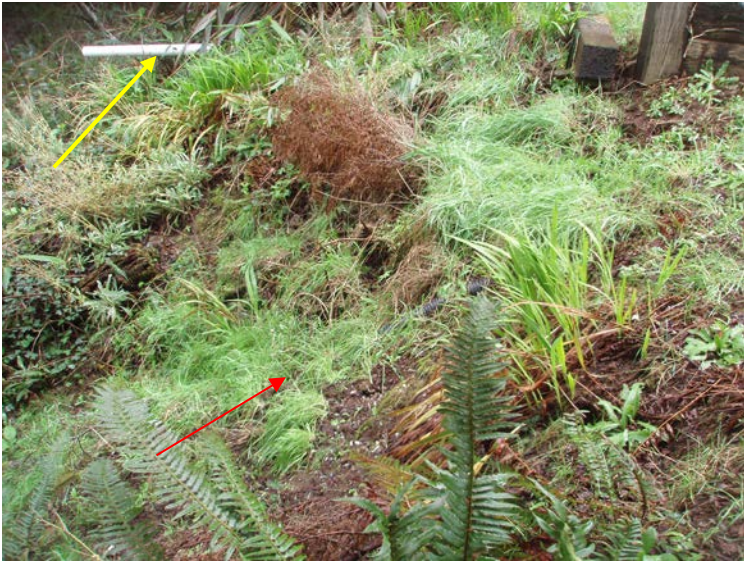
Drainpipes (center and upper left) discharging to slope. Vertical post in upper right is on east boundary of subject property.

- Storm water run-off, including downspout and footing drain discharge, from any structure constructed on the property should be managed in a way to prevent ponding, flooding, or excessive erosion or sedimentation. Existing and new drainpipes should be routed away from the sloping northern portion of the property or extended beyond the northern property boundary and to the Ferry Creek drainage.

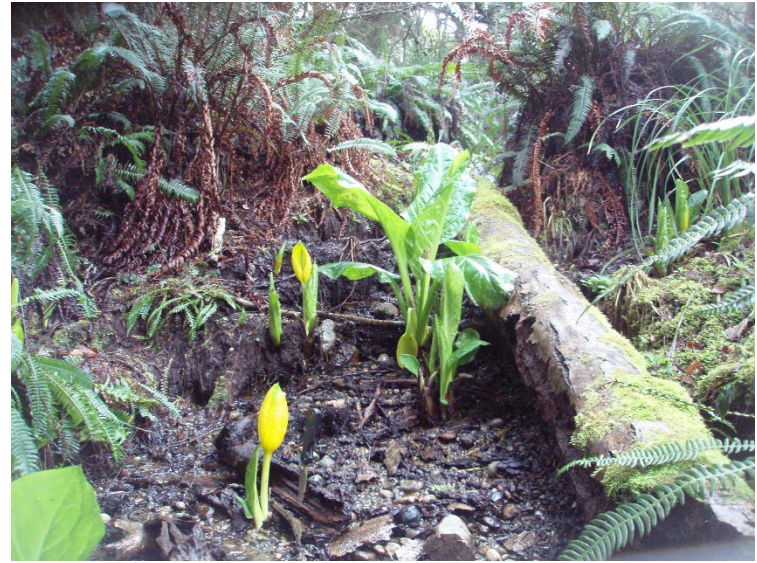
Gravel exposed downslope from spring.

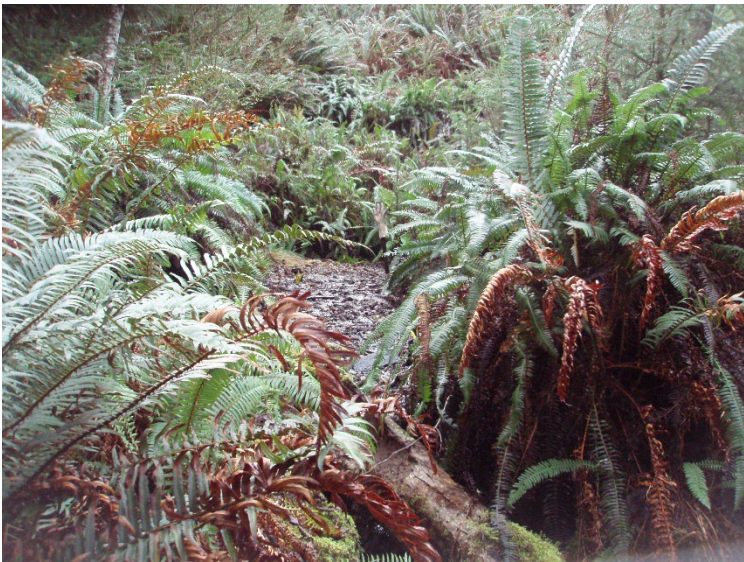
Spring discharging from slope north of ADU.
