Technical Memorandum

Reconnaissance-Level Geologic Hazard Assessment

1107 6th Street Southeast
Bandon, Oregon 97411

July 29, 2022

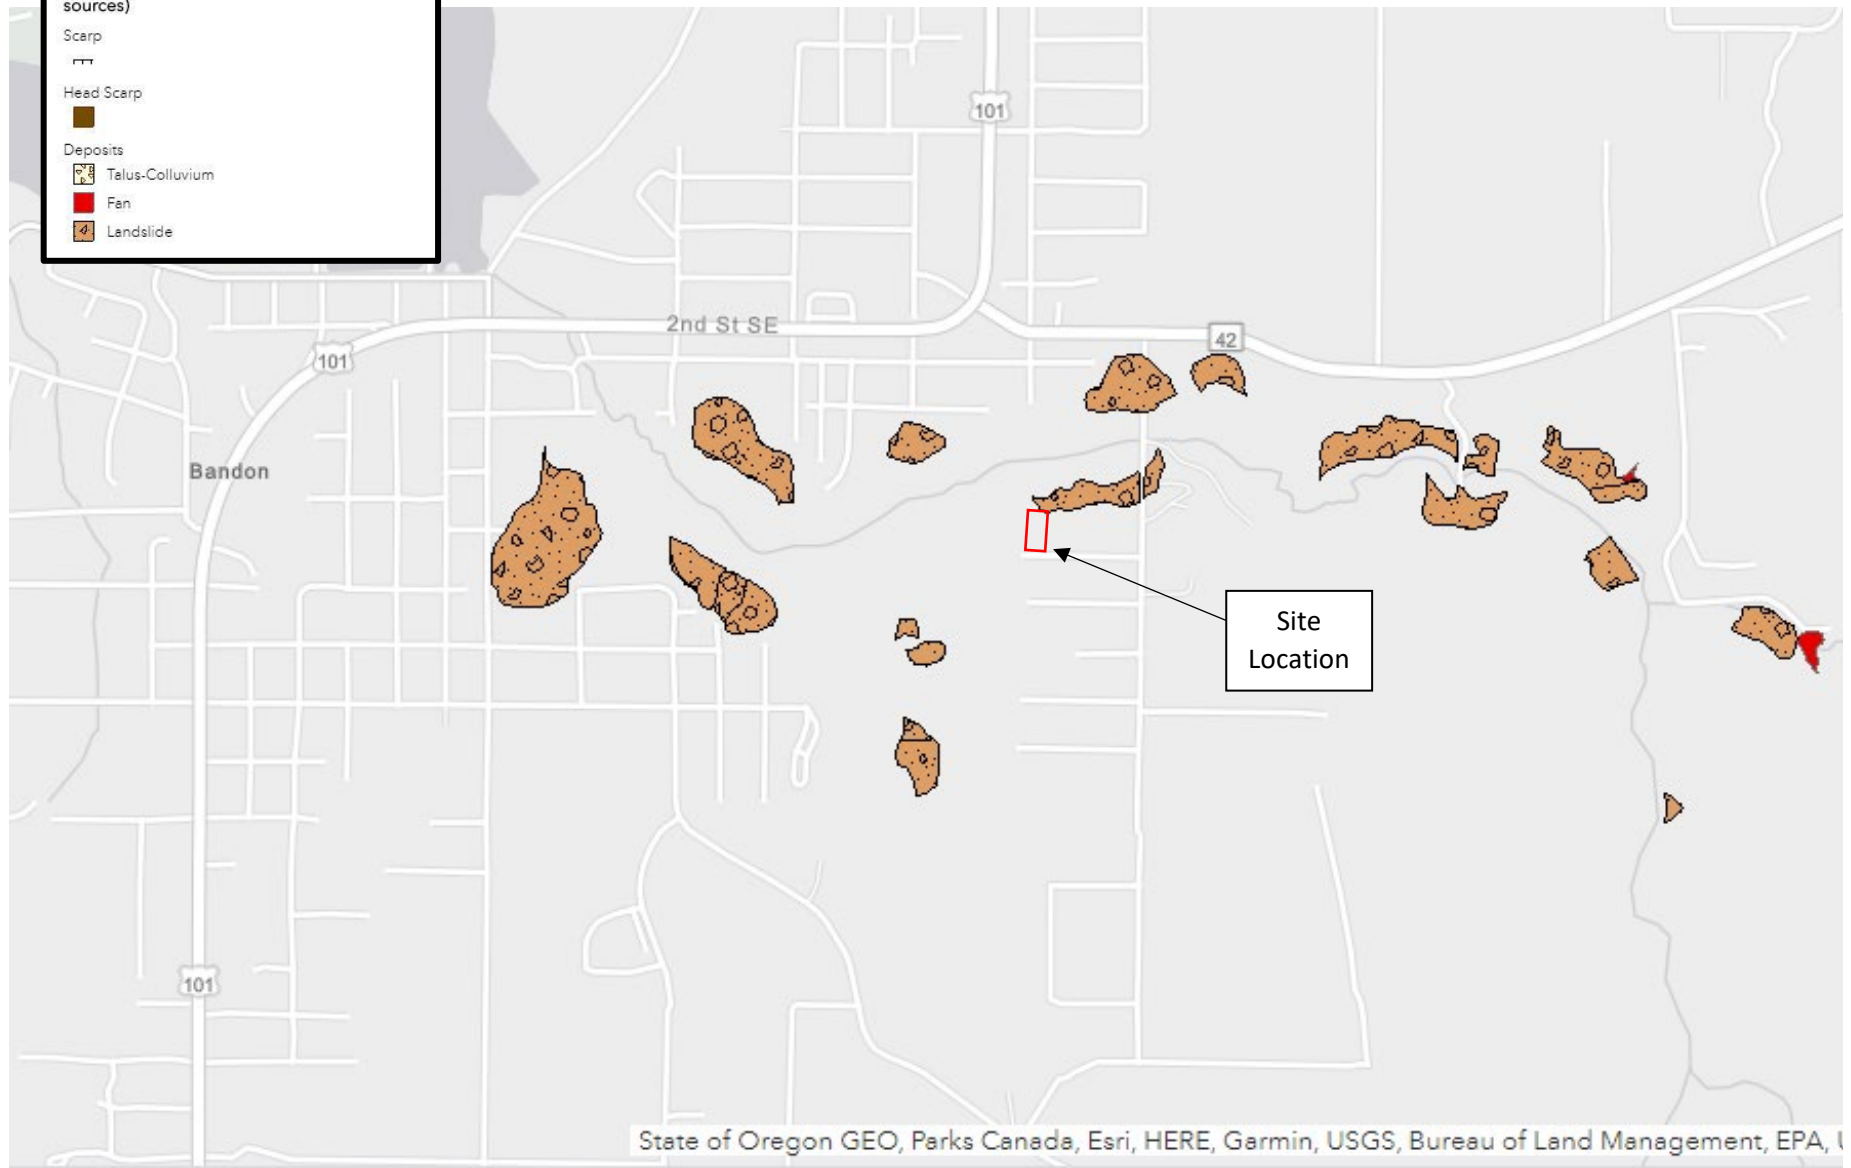
Project No.
 959-22001
 Figure No.
5a

Mass wasting events have been mapped within the immediate area of the subject site (Figure 5a and 5b), and the State has indicated that the landslide susceptibility hazard is low to moderate on the flat-lying southern portion of the site and high to very high on the steeply sloping northern portion of the site (Figure 5c).

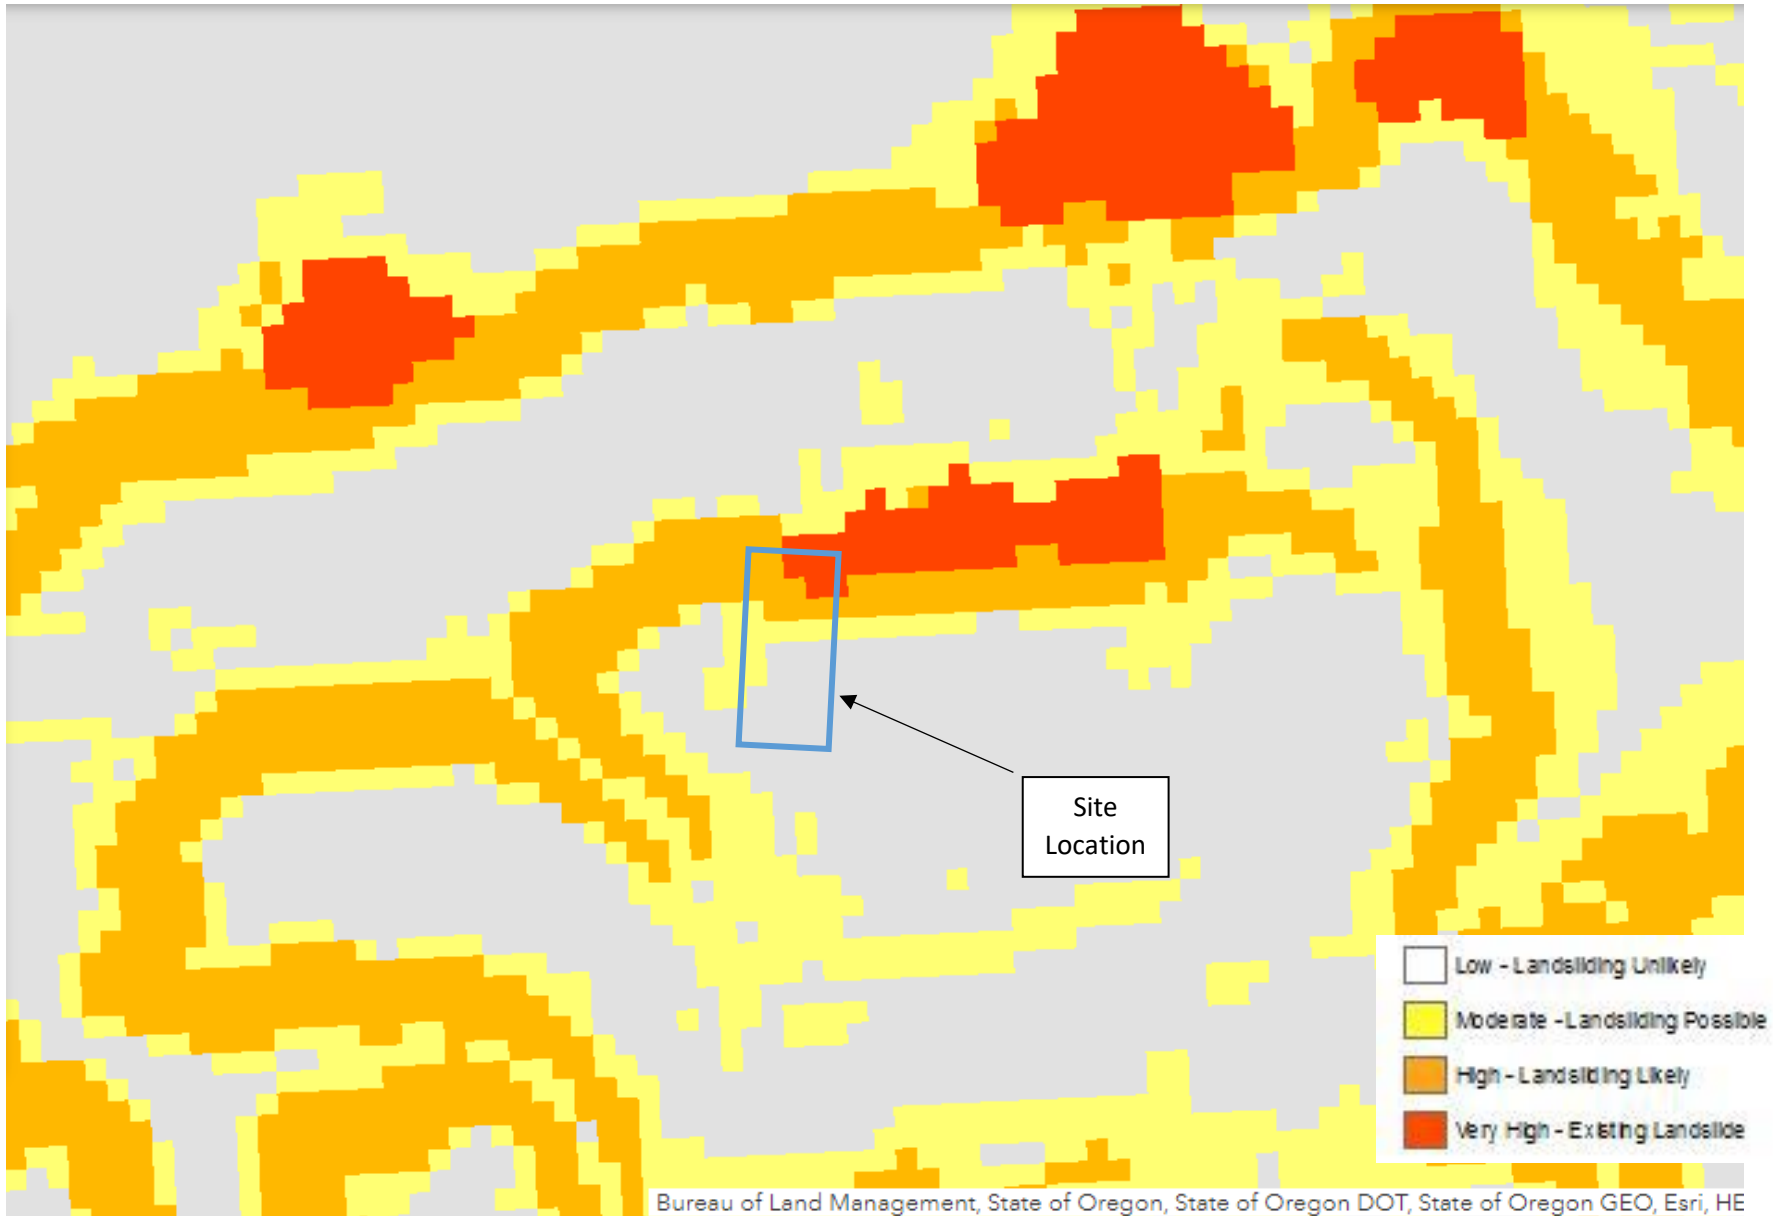
Project No.
 959-22001
 Figure No.
5c

- It is anticipated that the load created by construction of a 20' by 40' garage at the proposed location on the northern portion of the subject property would increase the potential for mass wasting.

- The property is subject to potential natural hazards and that development thereon is subject to potential risk of damage from such hazards. If the location of the proposed garage cannot be moved at least 25' back (south) from the break in slope, the services of a geotechnical engineer should be used in designing the foundation for that structure.

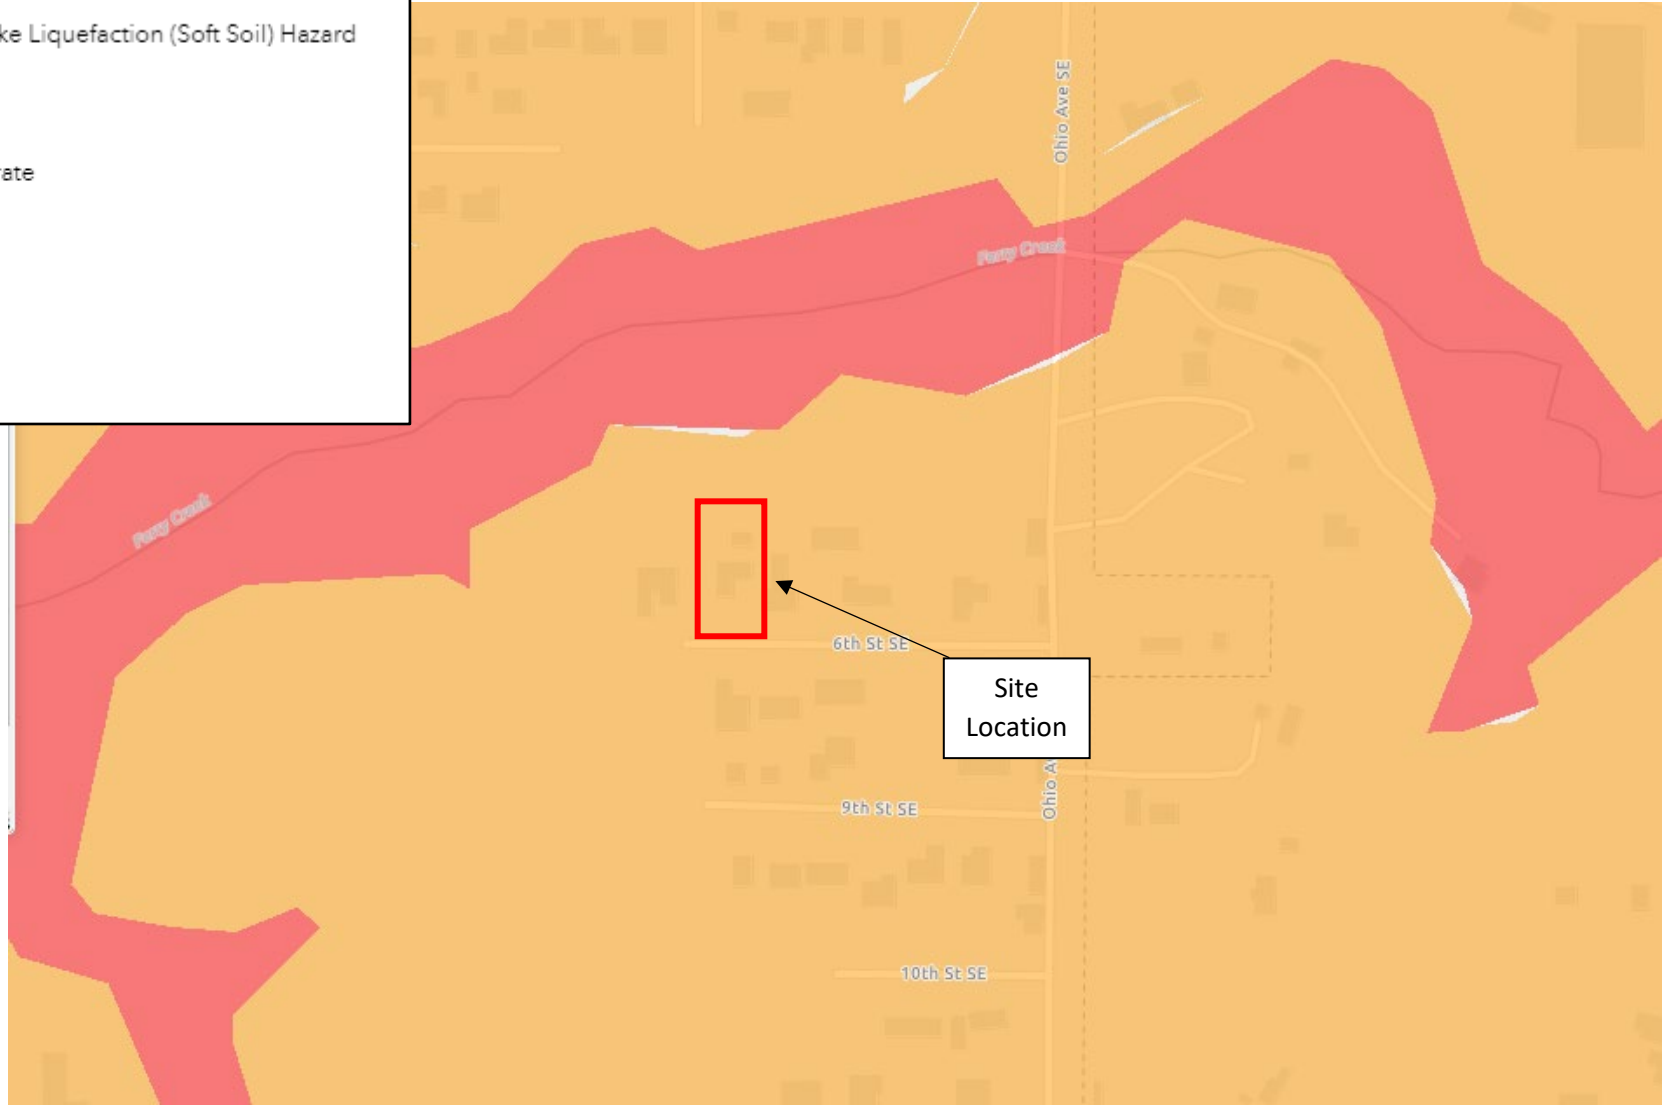
<p>Date Drawn: 3/15/2022 CAD File Name: 959-22001-01_fig7A_EarthquakeLiquifactionMap(v01) Drawn By: CLR Approved By: LDG</p>	<p>Residential Property 1107 6th Street SE Bandon, Oregon</p>	<p>Earthquake Liquefaction Map</p>	<p>Project No. 959-22001 Figure No. 7a</p>
---	---	--	--	--

No subsurface exploration or testing was completed by ENW for this project; however, saturated fine-sandy soils were reportedly encountered during construction of some area wells. These materials are known to have a high liquefaction risk. Earthquake liquefaction hazard is moderate at the subject site (Figure 7a).

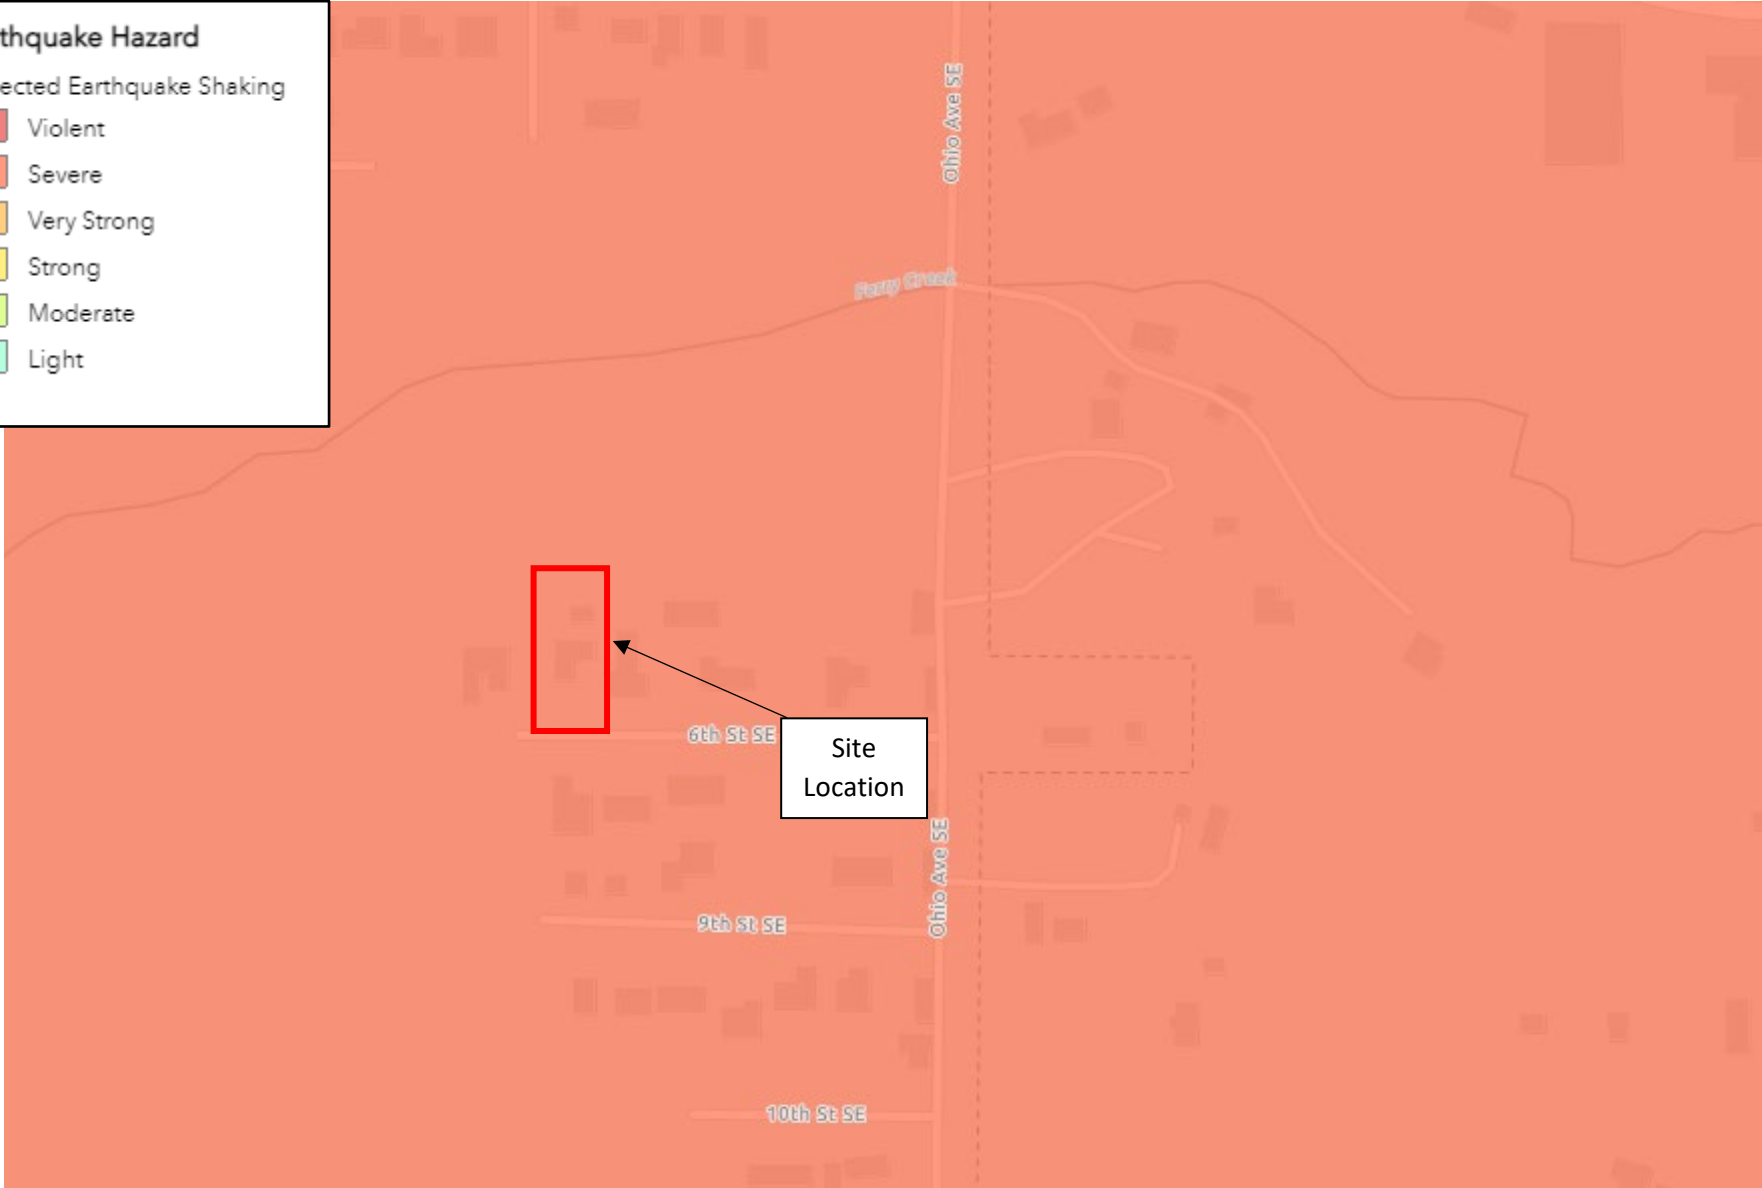
Project No. 959-22001
 Figure No. **7b**

The subject site is within the area of the state where peak ground accelerations of 55% of gravity can inflict considerable damage in specially designed structures and great damage in ordinary structures during an earthquake occurring once in every 1,000 years⁵. Earthquake shaking potential at the site and surrounding area is expected to be severe (Figure 7b).

- We recommend quantifying the severity of ground motions at the site and/or designing the home to prevent collapse during a worst-case scenario to minimize injury and/or loss of life to the structure's occupants.

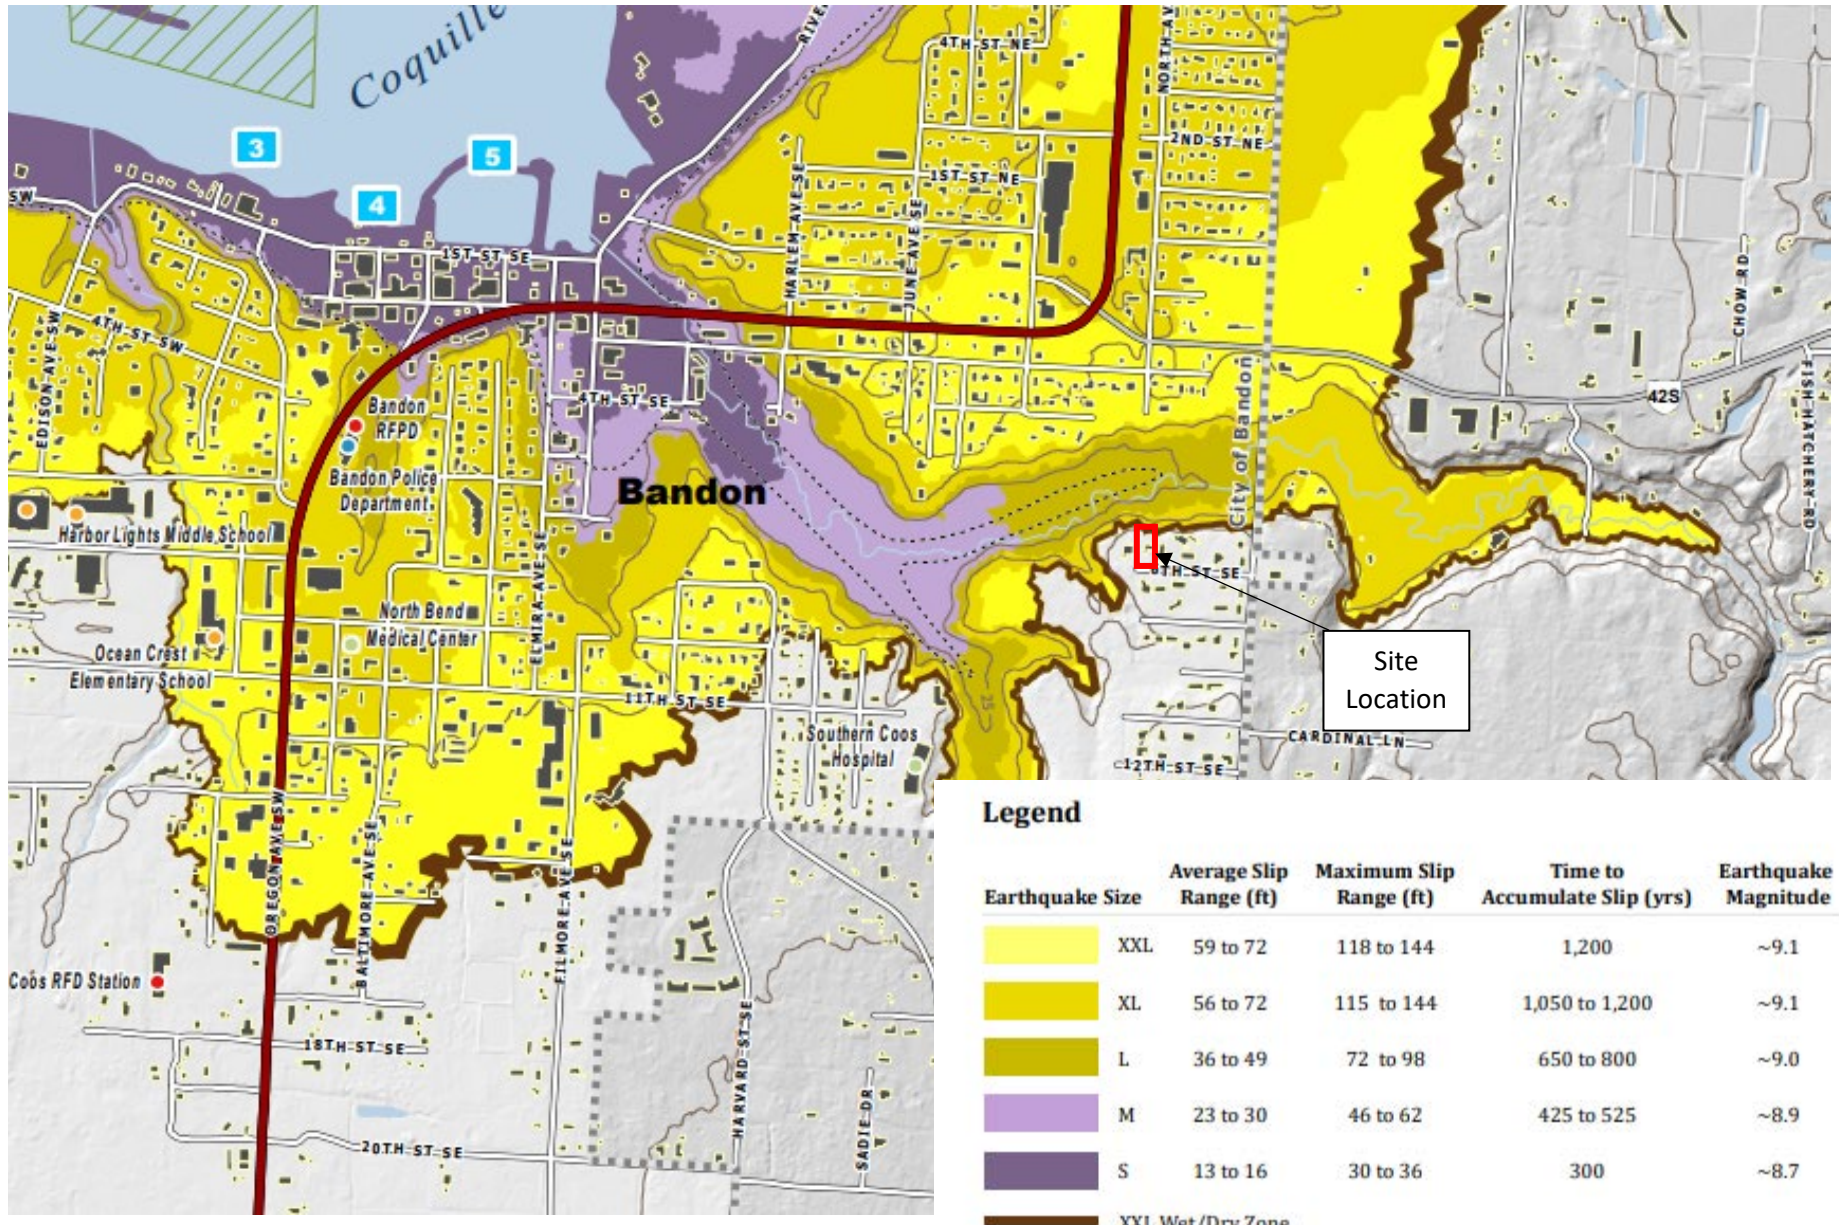
Project No.
 959-22001
 Figure No.
8

DOGAMI's tsunami inundation map⁶ (Figure 8) displays the output of its computer models representing five (5) selected tsunami scenarios (S, M, L, XL and XXL), all of which include the earthquake-produced subsidence and the tsunami-amplifying effects of the splay fault, which roughly parallels the CSZ. This model predicts that the subject site is largely outside the area that would be inundated by a tsunami under the less frequent L, XL and XXL scenarios, which correspond to an approximate magnitude 9.1 earthquake. It has been just over 300 years since the last CSZ event. Based on modeling by the State, the maximum wave elevation generated by an "L" event would be about 50 feet, and nearly 80 feet by an XXL event. The estimated time required to generate the energy necessary for L and XXL events is greater than 650 years. The estimated time required to generate the energy necessary for smaller events (S and M) is 300 years or more.

- Based on the State's models, only the furthestmost northern reaches, i.e., lowest elevation part of the slope, of the subject site would potentially be impacted by an XXL event, which is estimated to take up to 1200 years to accumulate enough energy to generate this size of an event.

- It is possible that the furthestmost northern reaches of the subject property could be inundated by a less frequent XXL tsunami scenario generated by a 9.1 or greater magnitude earthquake along the CSZ. The owner of the subject property should be aware of and prepared for such an event. There are many helpful emergency preparation and planning resources particularly designed for tsunami response, to name a few:

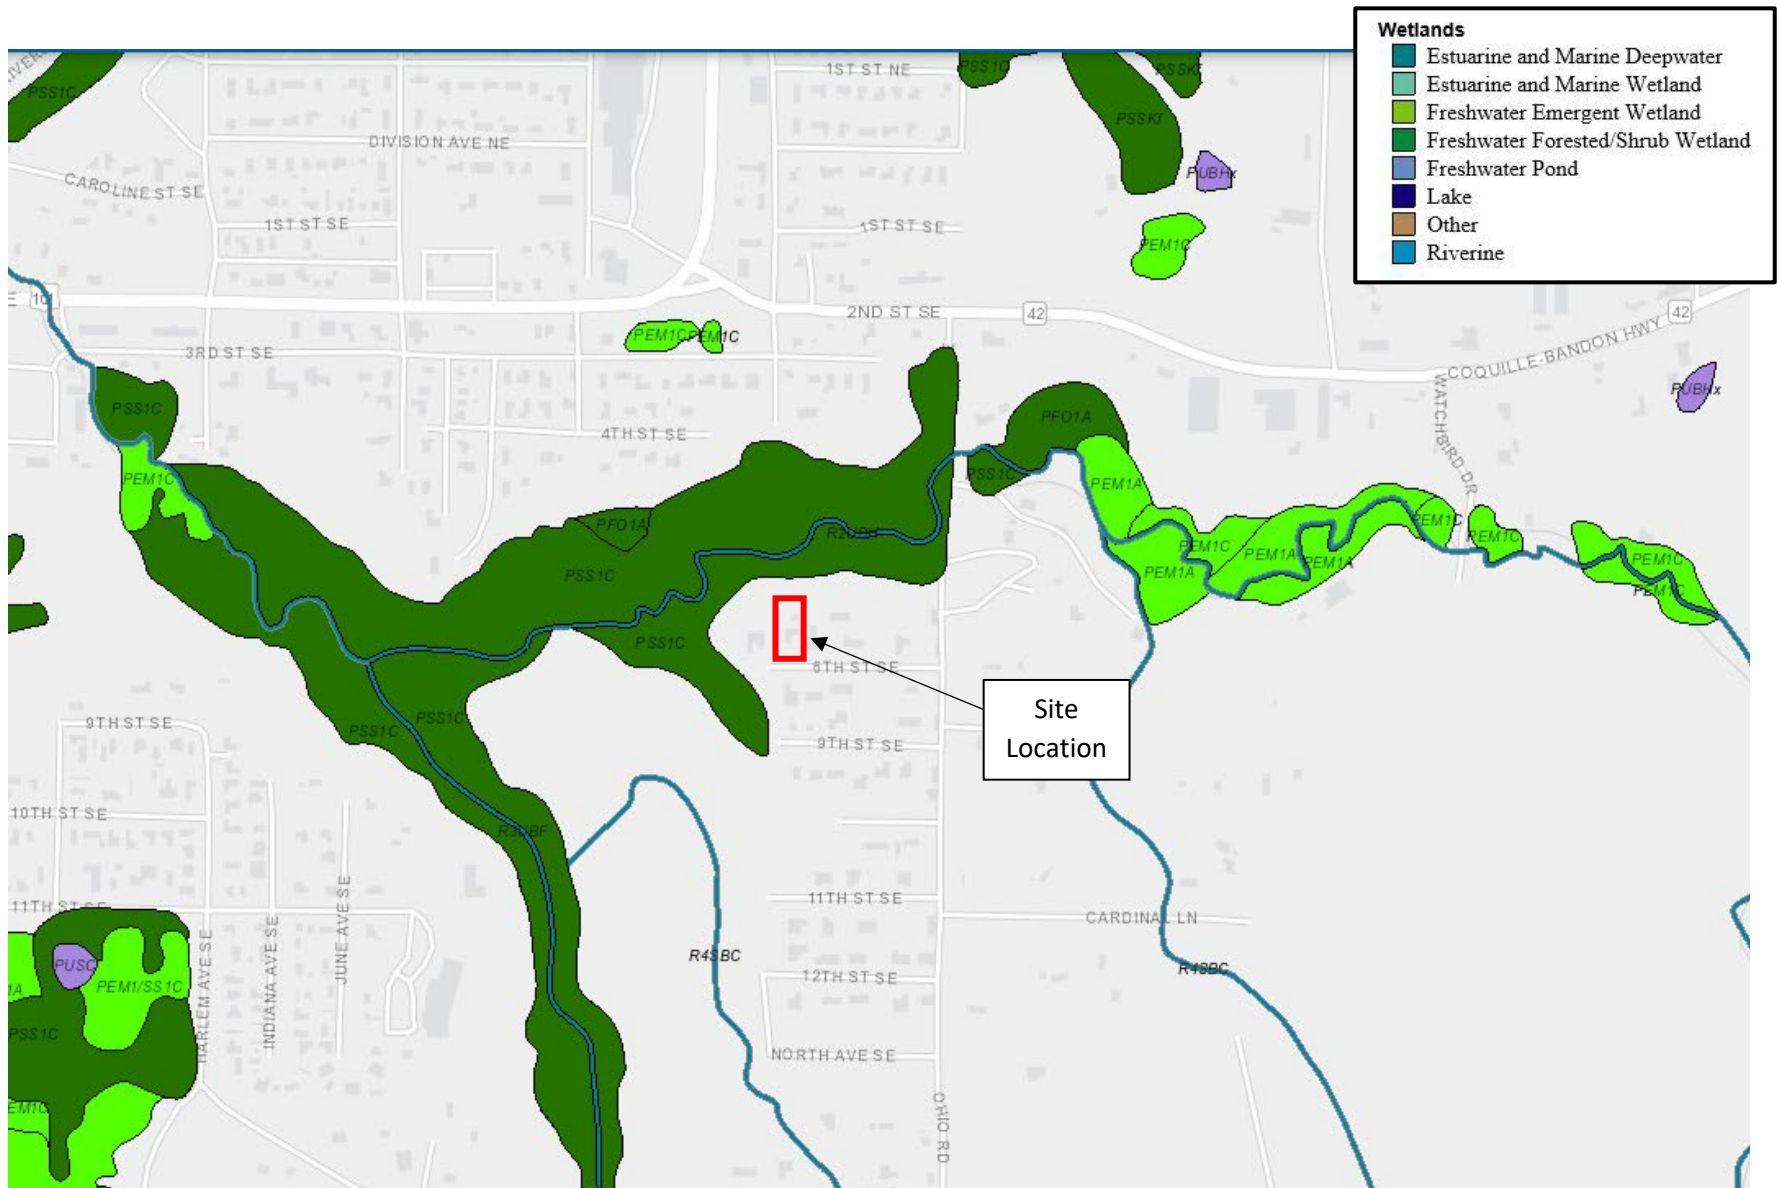
<p>Date Drawn: 3/15/2022 CAD File Name: 959-22001-01_fig8_WetlandInvMap(v01) Drawn By: CLR Approved By: LDG</p>	<p>Residential Property 1107 6th Street SE Bandon, Oregon</p>	<p>Wetland Inventory Map</p>	<p>Project No. 959-22001 Figure No. 9</p>
---	--	--	--	---

Based on information provided by Coos County and the US Fish and Wildlife Service, there are no inventoried wetlands on the subject property (Figure 9). Based on ENW's observations, there are significant wetland areas in the Ferry Creek drainage north of the site.

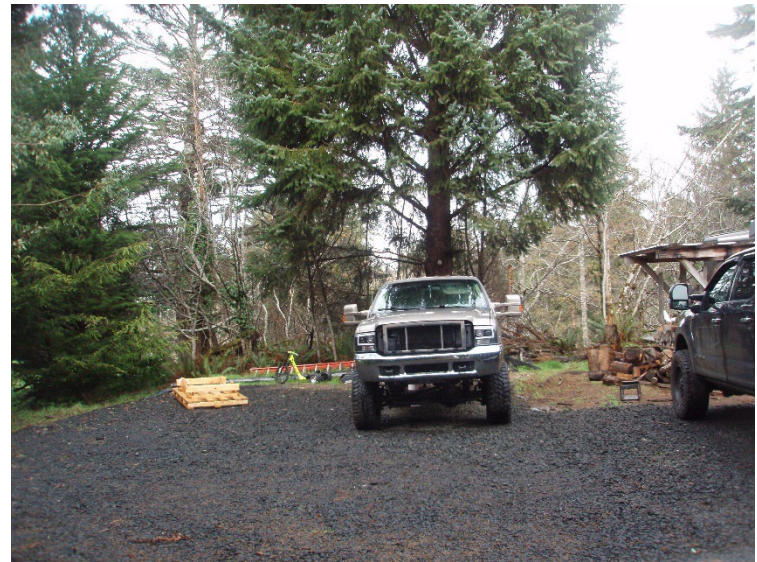
Proposed site of garage/shop building – looking north from the driveway on the west side of the property.

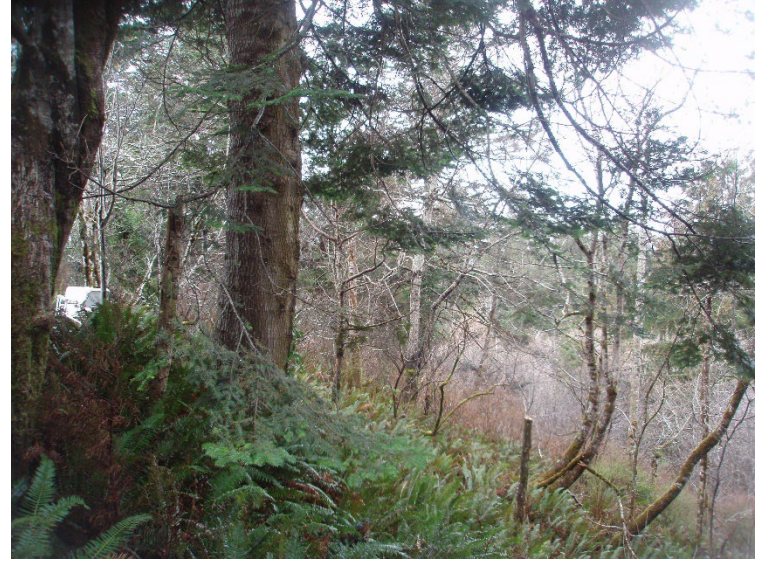
Looking west-northwest from near the northeast corner of the studio. Note bowed trees lower right.

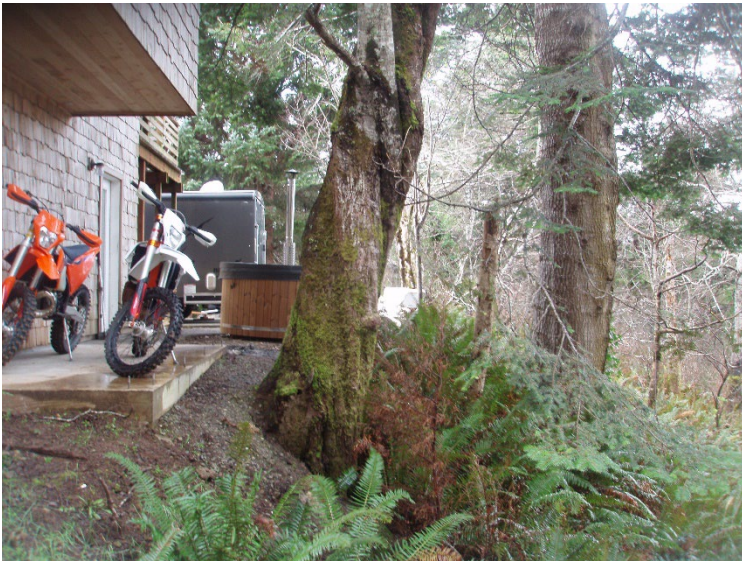
Looking west at the steep slope along the north side of the studio.

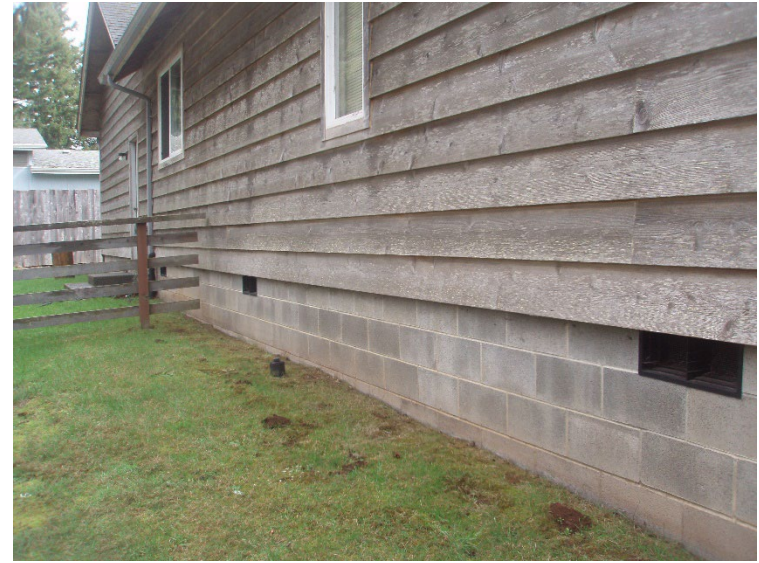
Masonry block foundation on north side of rental house – view east.

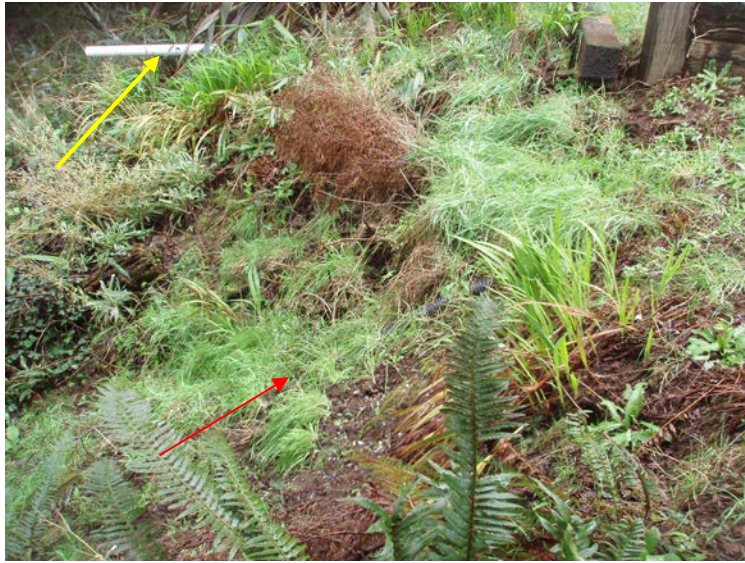
Drainpipes (center and upper left) discharging to slope. Vertical post in upper right is on east boundary of subject property.

- Storm water run-off, including downspout and footing drain discharge, from any structure constructed on the property should be managed in a way to prevent ponding, flooding, or excessive erosion or sedimentation. Existing and new drainpipes should be routed away from the sloping northern portion of the property or extended beyond the northern property boundary and to the Ferry Creek drainage.

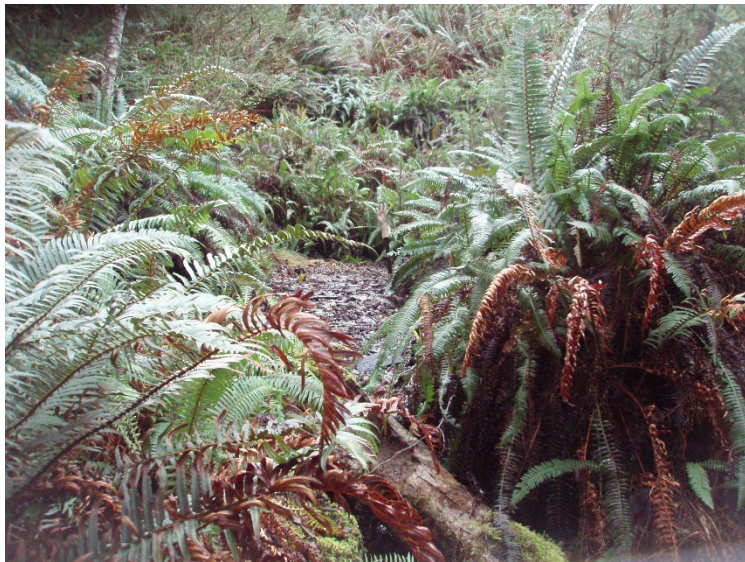
Spring discharging from slope north of studio.

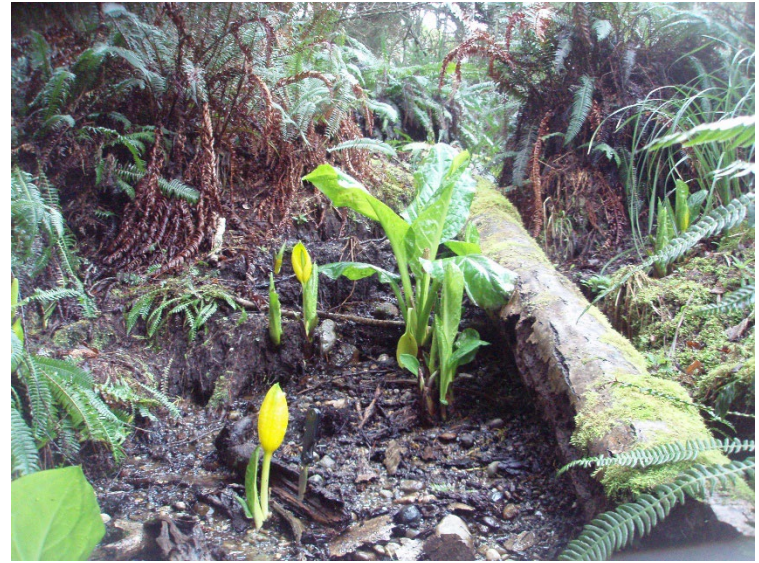
Gravel exposed downslope from spring.
