Amy LeBaron & SCBEC

710 E 17th St. Eugene, OR

3/31/21

CERTIFIED INSPECTIONS NORTHWEST

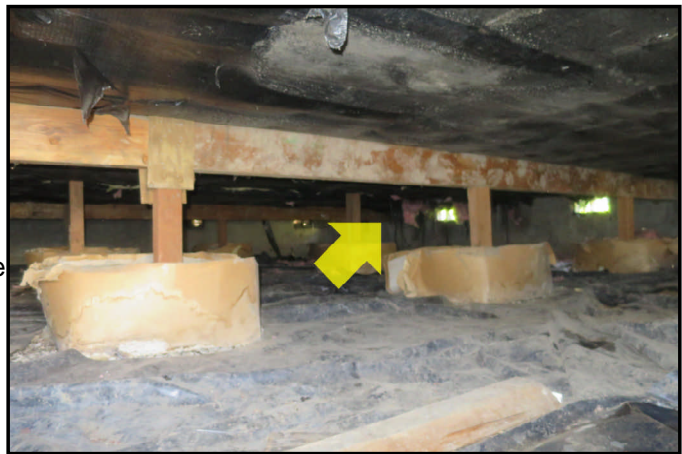
219 INSULATION As is typical of a modular building the insulation, as well as the wood joist framing system is concealed behind a heavy "travel-membrane", and is not visible for inspection. Some of the membrane has been opened (at north and south ends) and insulation has been torn away by animals. We recommend further evaluation and repairs as needed in these areas. Membrane should be secured (typically with wood and staples, as well as specialized tape).

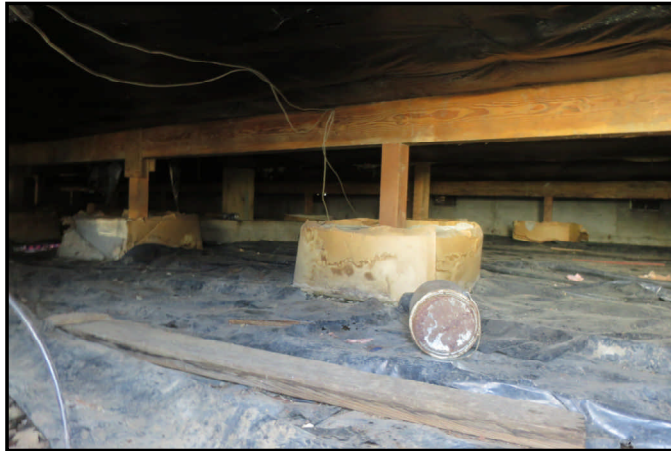
225 COMMENTS

We recommend include the main beams, for use at the new location. 4x4 posts and perimeter skirting might also be useful.

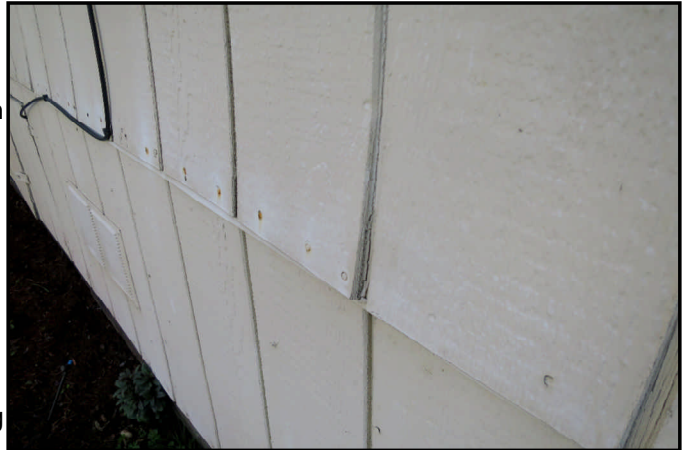
310 COMPOSITE SIDING

[CTM] The wood composite siding appeared functional, with some deterioration (swelling) noted at bottom edges, especially along the west side. The service life of this product may be extended with proper care and maintenance. We recommend periodic cleaning and re-sealing (primer / paint) bottom

edges, end-edges at trim, and any exposed nail heads. Check, and re-caulk as needed around window and door trim. As with all siding, keep irrigation spray directed away, and vegetation trimmed back from the material to provide adequate ventilation. In general, we recommend continue to monitor, make repairs as needed, and budget for replacement.

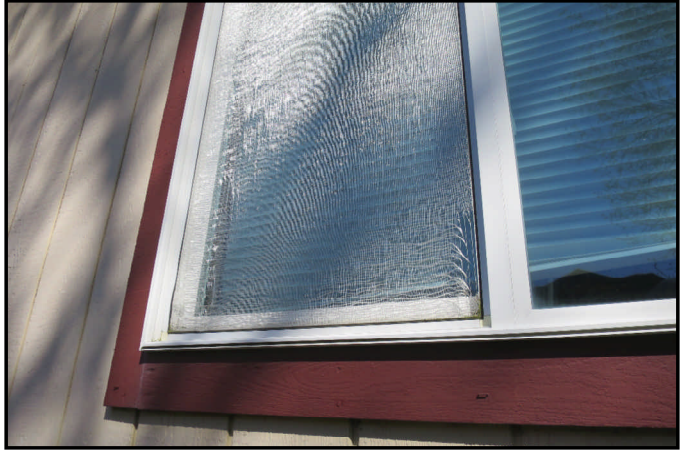
334 WINDOW(S)

Thermally glazed windows with vinyl frames. The windows as viewed from the exterior appeared functional, with exceptions noted: [FE] One or more screens are damaged or missing. We recommend further evaluation if this is a singular concern.

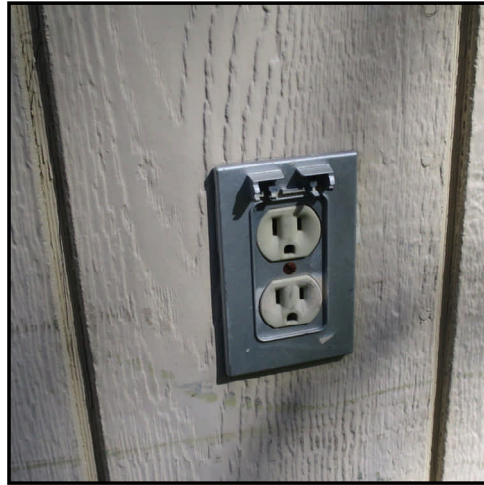
341 RECEPTACLE(S)

[CR] Receptacle cover plate was missing. We recommend correcting the condition(s) noted.

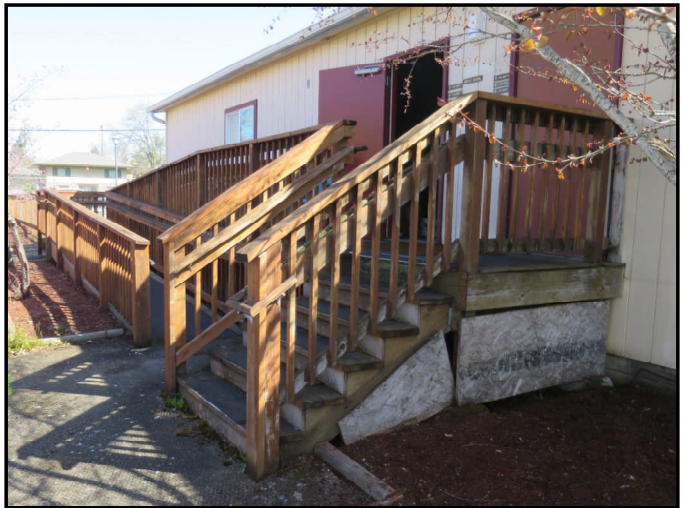
363 MAIN ENTRY

The entry deck appeared functional with signs of aging and wear. Some of the surface boards appear worn, but are partially concealed by matting. We recommend further evaluation if this is a singular concern.

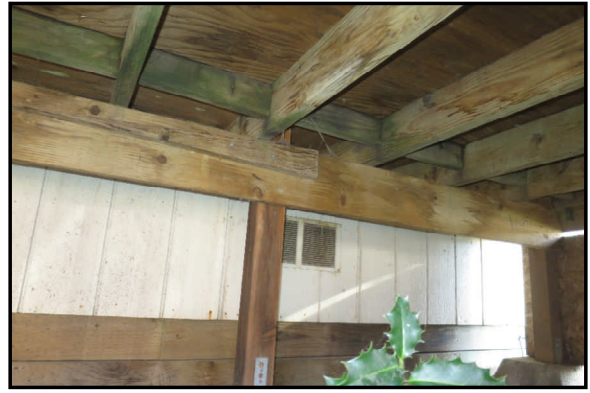
Deck framing materials appear generally strong.

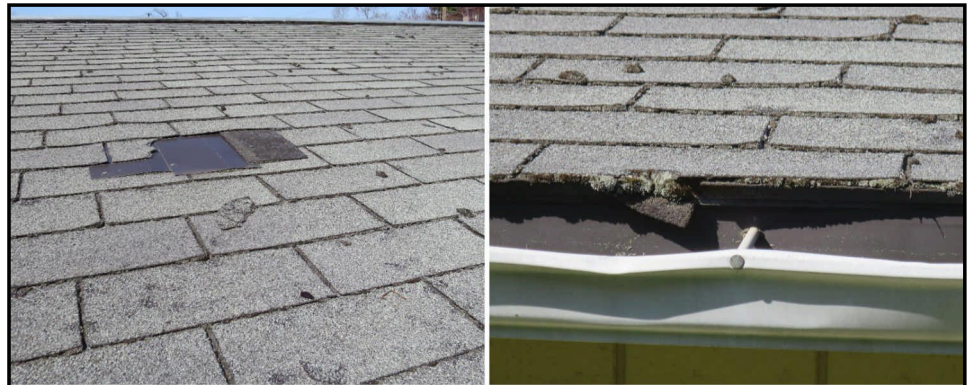
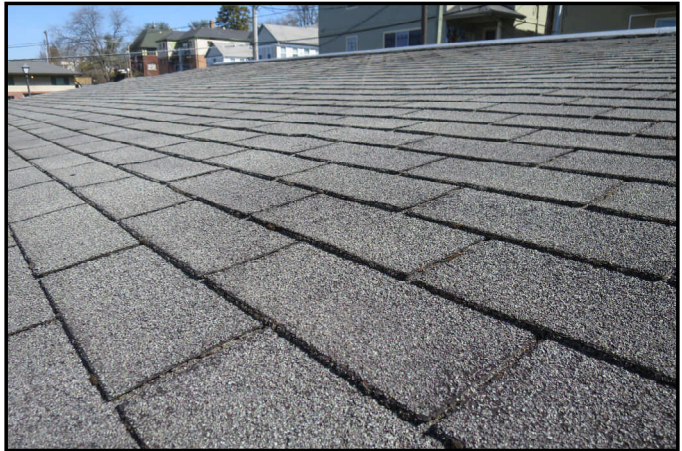
412 COMP. SHINGLE

[CTM] The visible areas of the roof appeared functional with general signs of weathering and aging, as well as a couple of areas of light damage (at the east side).

The granule and elasticity appear in fair condition. With professional repairs of the existing damage, and periodic inspection maintenance, this roof could achieve several more years of service.

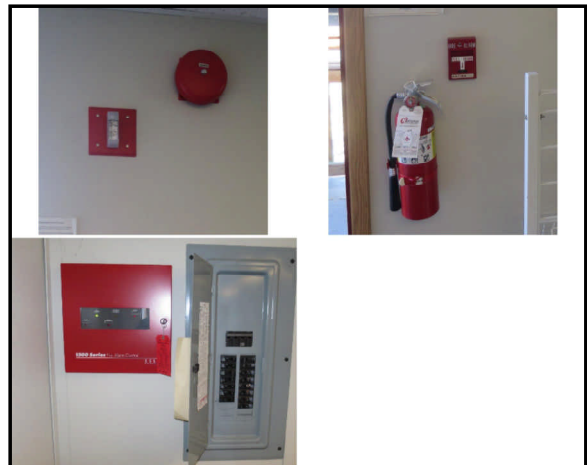
629 CONTROLS

[FE] The fire alarm system(s) were not evaluated. We recommend further evaluation by a specialist or the fire marshall in the new municipality.

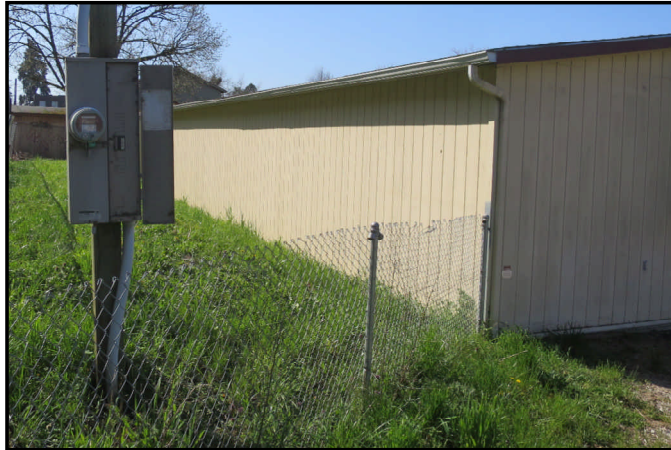
809 MAIN PANEL

[RU] The main Electrical Panel and the wiring within the panel appeared functional. Electrical service wire and conduit appeared functional. We recommend including the Main Electrical Panel, service-wires and Conduit tubes for use at the new location.

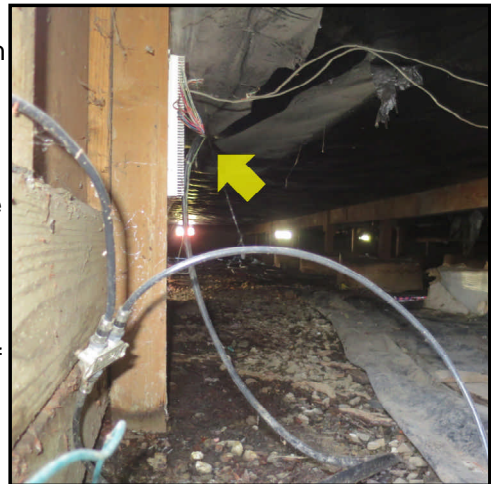
813 COMMENTS

[FE] NOTE: LOW VOLTAGE WIRING: There are telecomm board(s) located in the crawlspace, which you may want to save for the new location. We recommend further evaluation if this is a singular concern. The testing or evaluation of low voltage wiring is beyond the scope of our inspection. This includes, but may not be limited to: phone lines, cable or satellite TV, alarm systems, audio/video, computer network cables, etc. If any of these services are desired we recommend contacting a qualified technician for further evaluation.

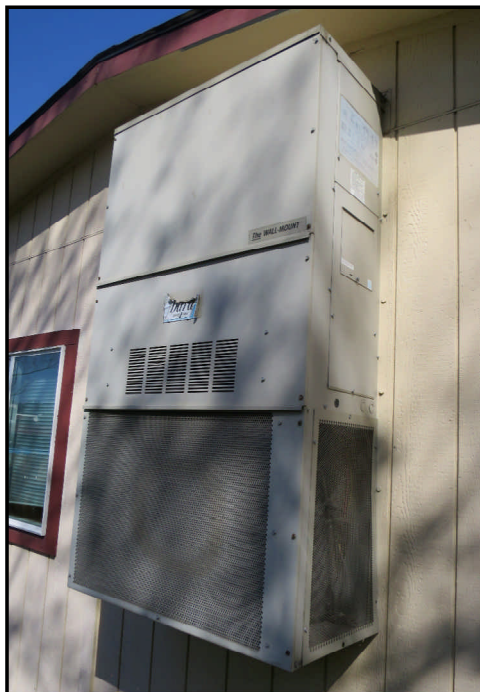
910 HEATING UNIT(S)

The HVAC units were functional as tested in heating mode. A main disconnect was not noted, which would allow a specialist to turn off power at the location. Filter(s) were not noted, but could be located behind the interior return wall grills.

[FE] Due to the age and high value of this heating / cooling system, the lack of service records, as well as the technical gauges and equipment required to effectively evaluate this, and all related components, we recommend further evaluation by a licensed HVAC specialist. One might also arrange for servicing if needed.

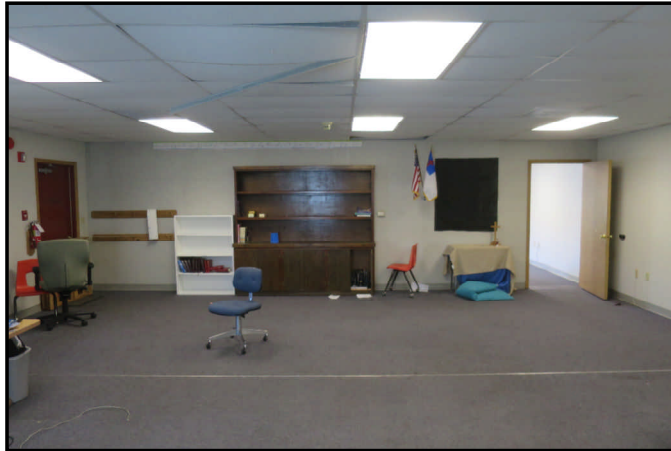
1407 WALL(S)/CEILING(S)

Finished gypsum board. The visible areas of the walls and ceiling panels appeared functional. [CR] Some of the ceiling panel frames are loose. We recommend further evaluation and repairs as needed.

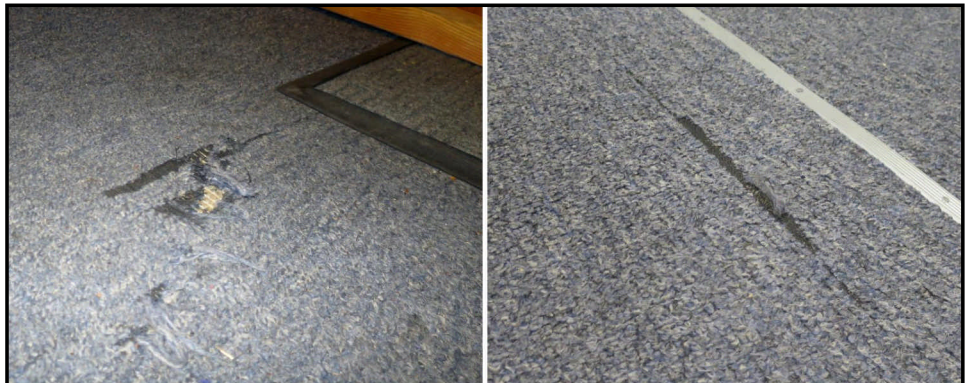
1409 FLOORING

[CTM] The visible areas of the carpet flooring appeared functional, with a couple of tears and some stains noted.

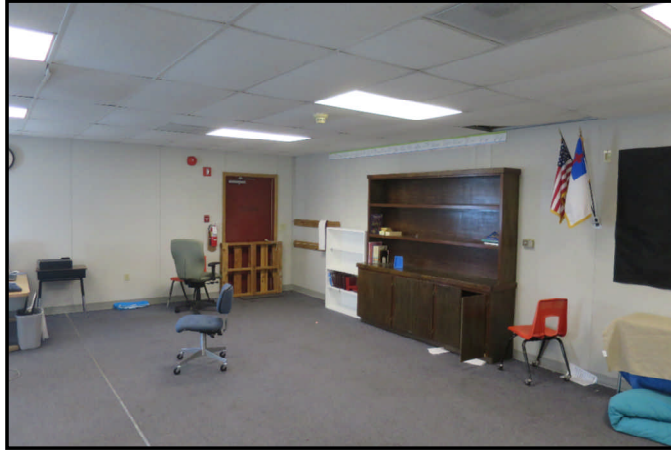
1415 EXTERIOR DOOR(S)

[CR] One of the exterior doors were missing hardware parts, and the door was sealed off at the time of inspection. We recommend further evaluation and repairs as needed by a specialist in the appropriate trade. See also notes at Exterior Doors 322.
