Geotechnical Site Evaluation

Beach Loop Road
Bandon, Oregon 97411
T29S, R15W, Sec 01BB, Tax Lot 02000

February 18, 2022
CGS Project No: 21126

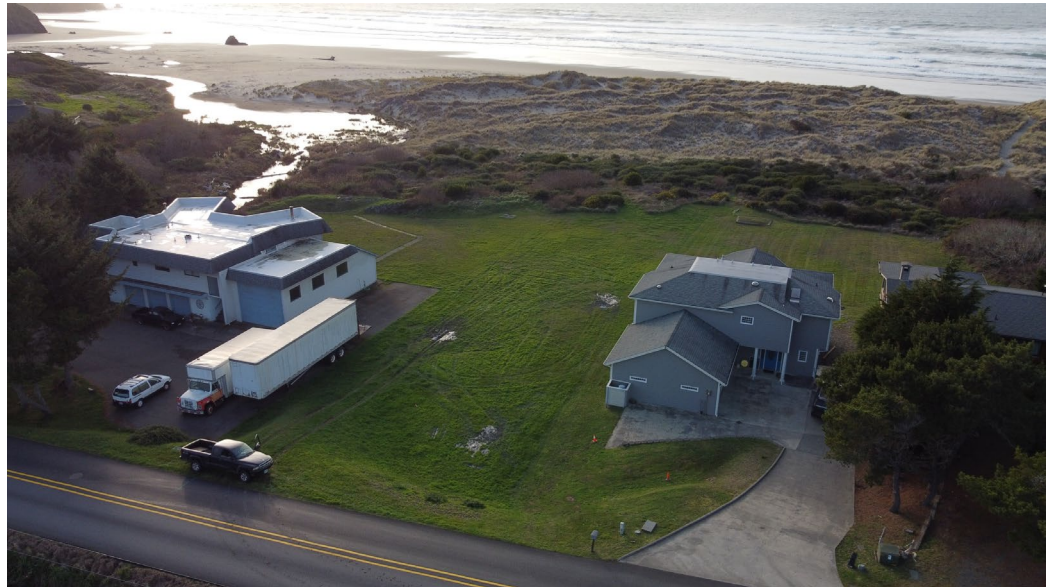
Tax Lot 2000 is approximately 320 feet long, measured east-west and is 19.0 feet Above Mean Sea Level (AMSL). The site adjoins undeveloped public beach land to the west and the western boundary extends over the statutory vegetation line. The western edge of the proposed building site is approximately 580.0 feet east of the western edge of vegetated relict foredunes. An area of dense exotic vegetation (gorse) along the western boundary of Tax Lot 2000 creates a transition between the site and the

foredunes (Photo 1). The vegetated dunes are approximately 10 feet higher in elevation than the building site. The building site is not impacted by coastal erosion processes.

Photo Description:

An area of dense exotic vegetation (gorse) along the western boundary of the site forms a transition between the site and the relict foredunes.

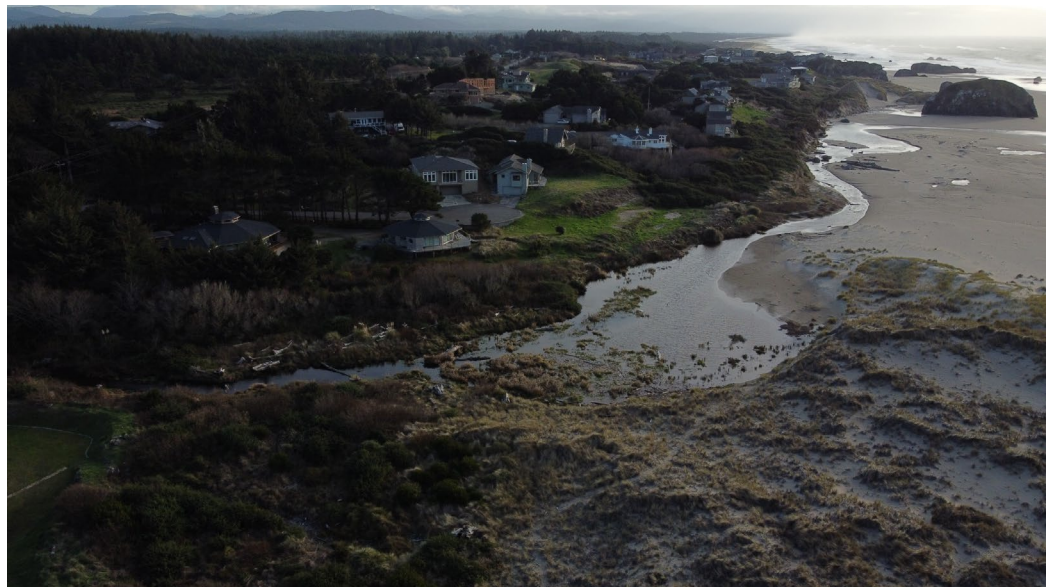
Photo No: 2

The site is located in what was the Johnson Creek drainage channel as mapped by the county¹ and is within the 100-year floodplain. Johnson Creek has been rerouted to the south (Photo 2) and flows under Beach Loop Road where it flows west and south. At the closest point Johnson Creek is 140.0 feet south of the site. Because the site is located in the flood plain, development of the site will have to be done in accordance with FEMA Floodplain Management Guidelines²

Photo Description:

Johnson Creek has been rerouted to the south of the site.

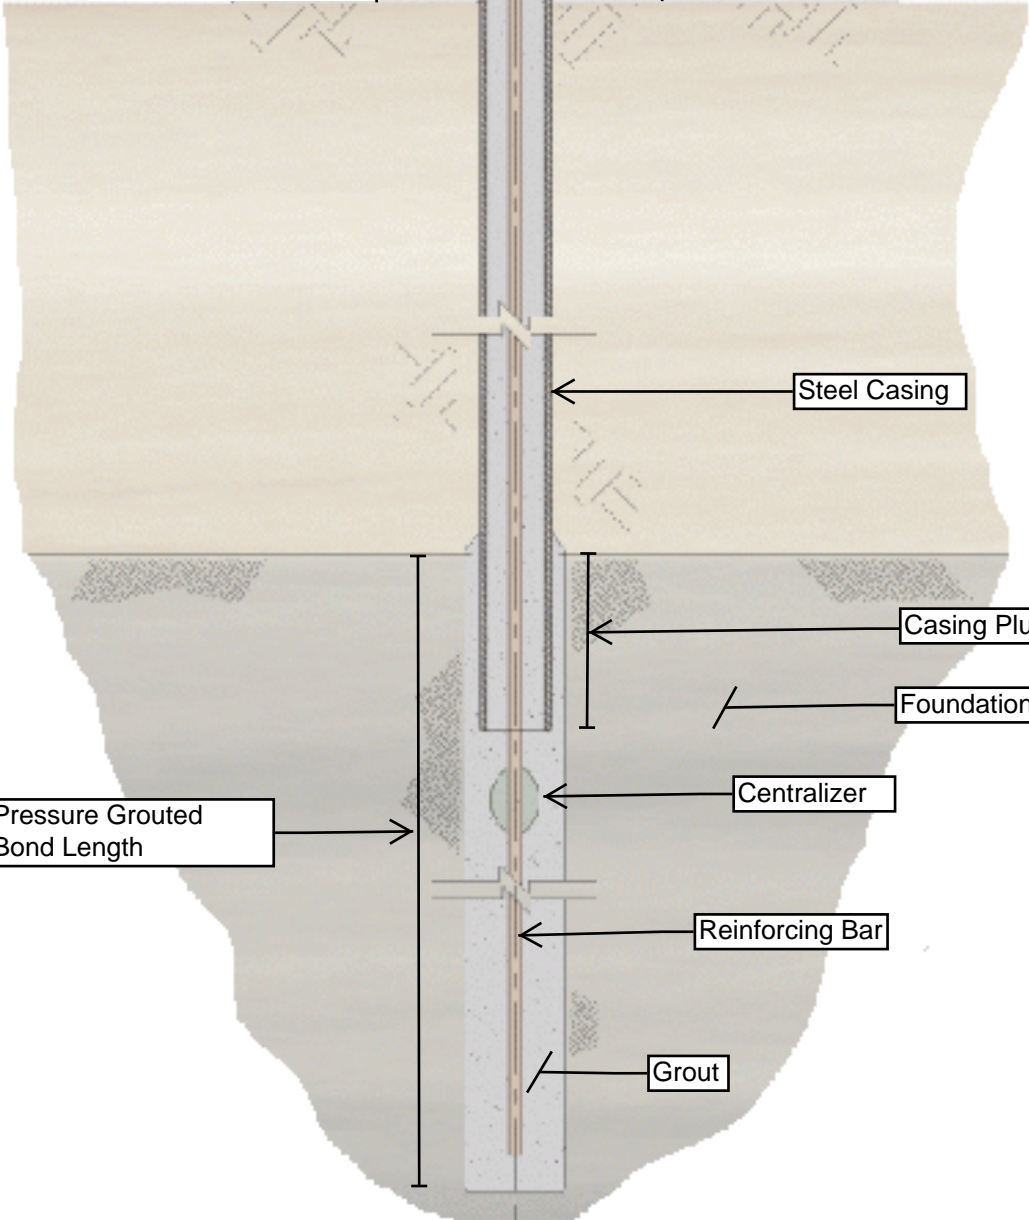
Pile installation is an industry standard performed by many contractors. Figure 3 shows key elements of a standard bored pile installation. The specific pile design and number of piles will depend on the compression, tension and lateral loads imposed on the foundation. These loads will be determined by your structural engineer based on the structure that you choose to build. Likewise, installation and testing should be the responsibility of the contractor who is in the best position to choose systems that fit the plan of operation. In general, we recommend that the foundation zone be no less than 30.0 feet bgs. This will socket the borings a minimum of 5.0 feet into the underlying sandstone bedrock. The piles should be installed in pre-bored holes. We do not recommend that the piles be driven due to concerns that vibrations may cause damage to surrounding structures. Because of the shallow water table, this will require that the borings be cased. The actual depth of the pile boring should be based on an additional exploratory boring and 5.0 feet of core at the bottom of the boring. A CGS engineering geologist (or their representative) should confirm suitable bearing conditions and evaluate all pile borings. Observations should confirm that loose or soft material, organics, unsuitable fill, and old topsoil zones are removed. Localized deepening of pile borings may be required to penetrate any deleterious materials.

The reinforcing bar and pipe dimensions and the grout-to-bond zone should be determined by your structural engineer as part of the overall pile design. Because of the corrosive marine environment, the reinforcing steel bars should

have a corrosion-protective coating. The pipe thickness can be increased to include "sacrificial steel" as a form of corrosion protection. The connection between the pile and the support pier and the connection between the pier and the house should also be determined by the structural engineer.

Casing is part of the pile structure so drilling through softer sands into the harder sandstone bedrock should result in a "clean" installation, except potentially in the uncased portion of the hole where the casing will be pulled up to expose the bond zone. Care should be exercised to maintain a relatively clean hole before grouting to avoid post-construction settlements of greater than ¼ inch. We recommend that during pile installation, the contractor have casing on-site in case it becomes necessary to case the borings.

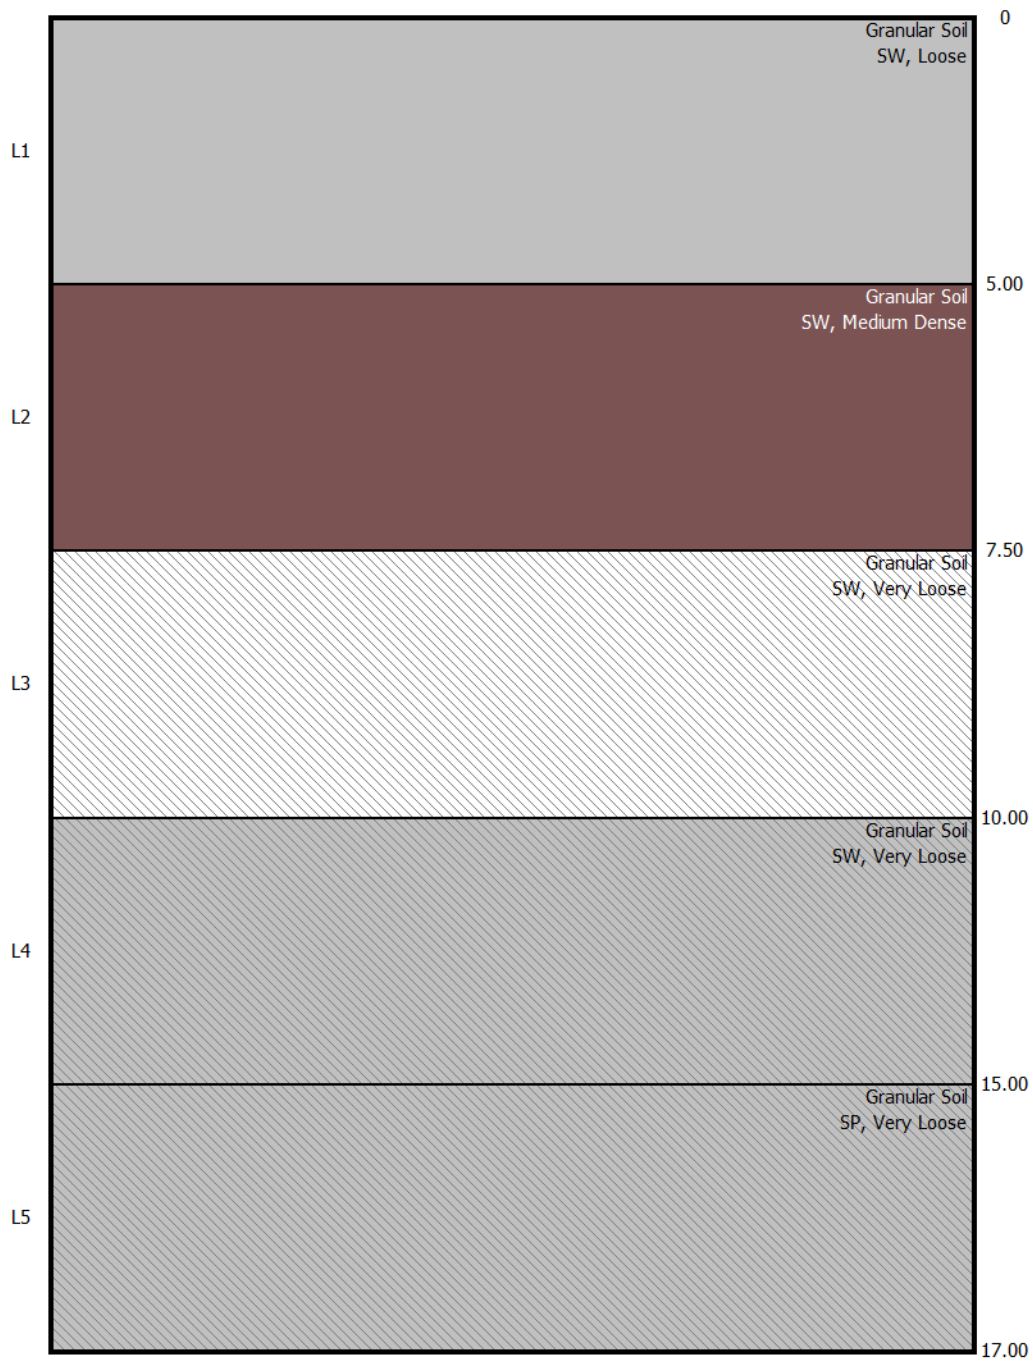
Fig. 1: Subsurface profile

Liquefaction occurs when loosely packed, water-logged granular sediments lose their strength in response to strong ground shaking. Liquefaction occurring beneath buildings and other structures can cause major damage. Liquefaction potential was assessed based on the information obtained from our borings and using the parameters suggested in Youd & Andrus, et al., 2001.¹⁴ According to our seismic analysis, the site will experience a peak ground acceleration (PGA) during a design seismic event of 1.011 g. Further, groundwater was observed in all of the borings at approximately 2.0 feet bgs. Our liquefaction analysis indicates that as much as 11.0 of settlement will occur during a design seismic event of 6.9 Mm. Our analysis is included at the back of the report as Appendix 3.

#	Material Type	USCS	Bottom Depth, ft	Consistency	Flags	SPT field	Fines Content, %	Energy Ratio, %
1	Granular Soil	SW	5.00	Loose	Unsaturated	10	3	50
2	Granular Soil	SW	7.50	Medium Dense		19	3	50
3	Granular Soil	SW	10.00	Very Loose		2	3	50
4	Granular Soil	SW	15.00	Very Loose		2	3	50
5	Granular Soil	SP	17.00	Very Loose		2	3	50

Settlement: 10.71 in
 Lateral Displacement: 0.00 ft

We commonly over excavate soft soils to mitigate liquefaction but because of the depth required to replace the soils and the shallow, near surface water table, this option is not feasible. Similarly, we commonly elevate structures using fill, but this is not allowed in a flood plain. Because of these issues, the only suitable means in which to elevate the structure and to mitigate liquefaction is to support the structure on bored piles.
