Geotechnical Site Evaluation

Beach Loop Road
Bandon, Oregon 97411
T29S, R15W, Sec 01BB, Tax Lot 02000

February 18, 2022
CGS Project No: 21126

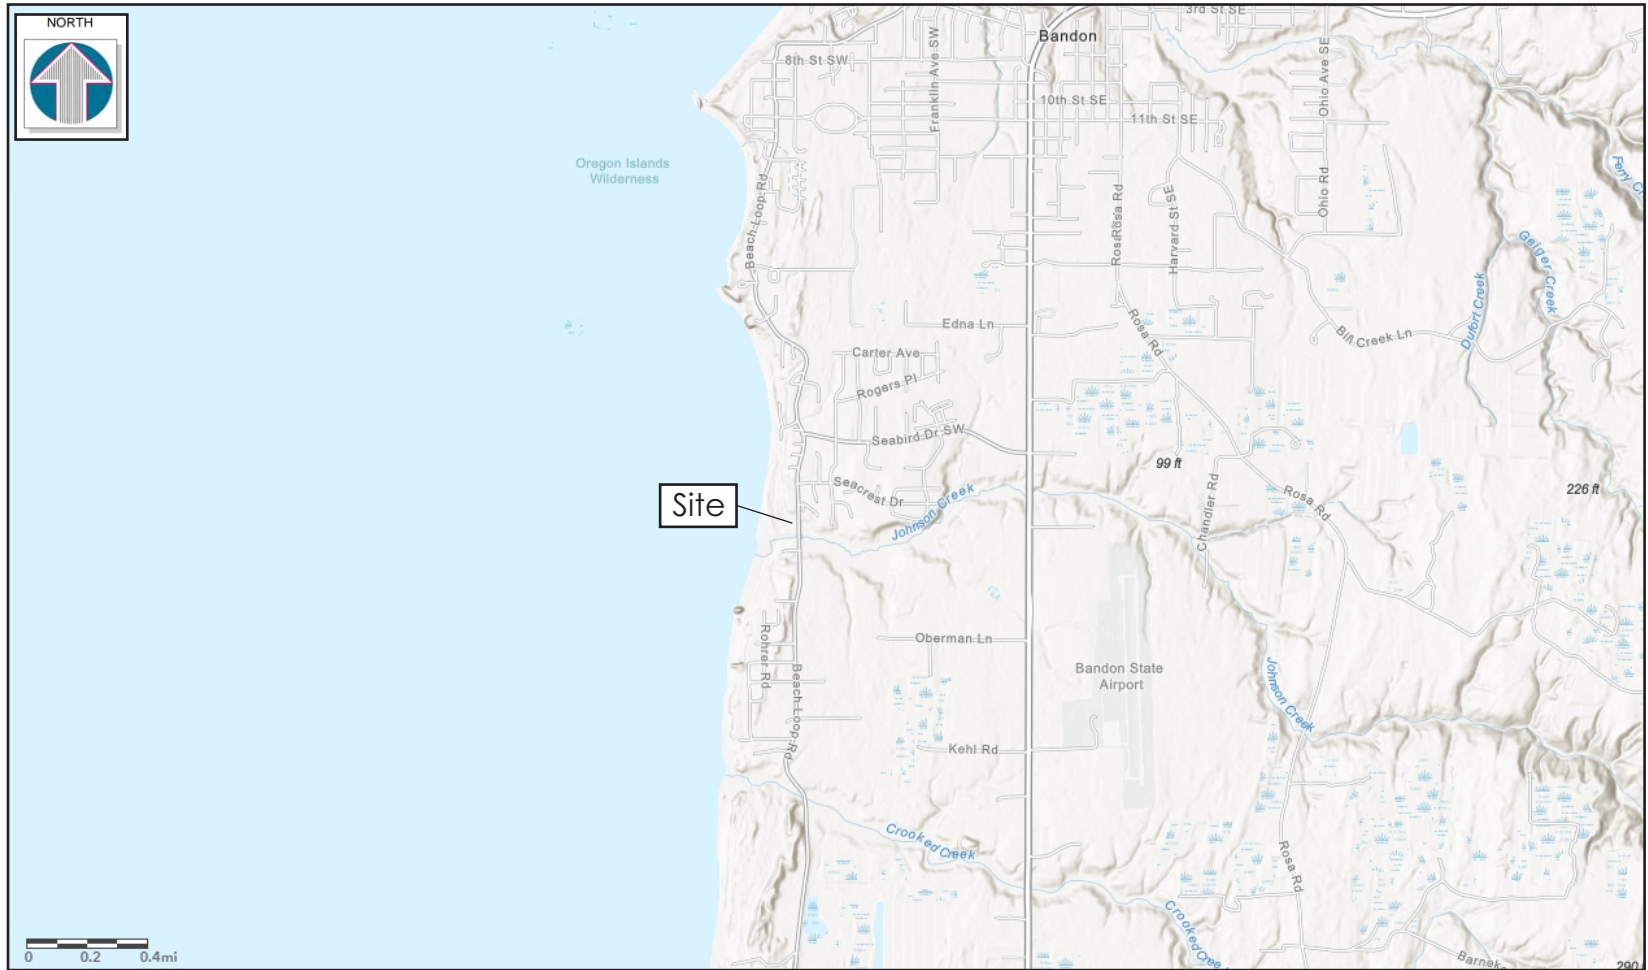
Figure
1

Location Map
 Geotechnical Site Evaluation
 Beach Loop Drive, Bandon, Oregon 97411
 T29S R15W Sec 01BB, Tax Lot 2000

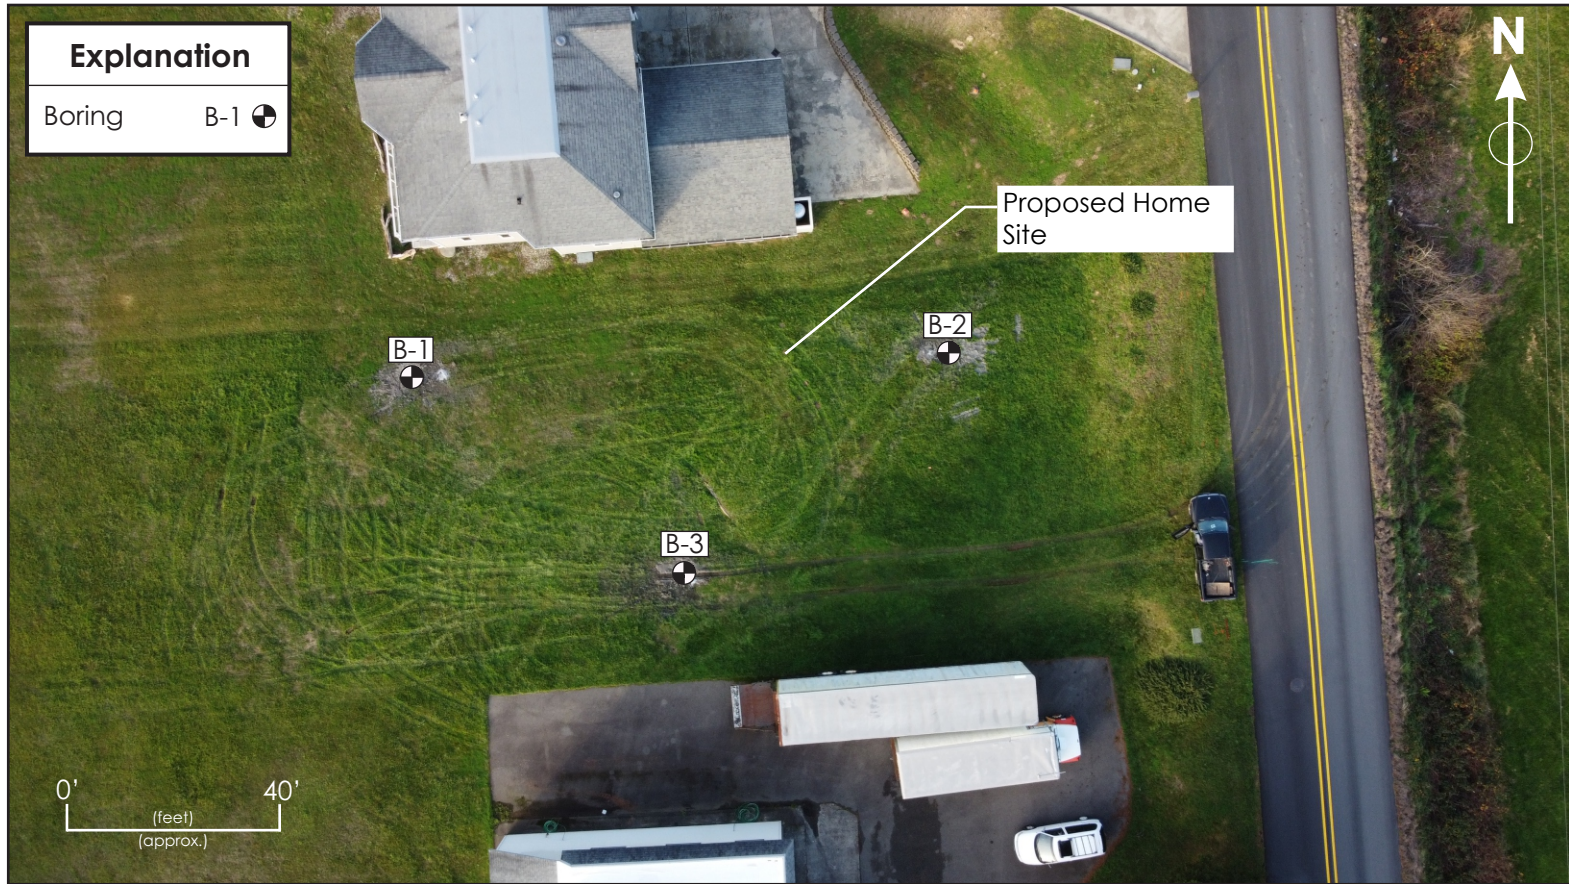
**Figure
2**

The site is located within the Klamath Mountain physiographic region of southwestern Oregon. Tax Lot 2000 is 0.49 acres and is in a residential area west of Beach Loop Road (see Figure 2, Site Map). The site is level, undeveloped and vegetated with mowed grass. The site is accessed from Beach Loop Road and a private unimproved driveway. The steep roadbed fill slope on the outboard side of Beach Loop Drive ascends 10 feet above the site on the eastern boundary.

techniques. Standard Penetration Tests (SPT)⁵ of the soils were completed at 2.5-foot intervals for the first 10 feet and 5-foot intervals thereafter. The borings were logged by a member of our staff from our Southern Oregon coast office. Soil samples from the borings were collected and stored in moisture proof plastic bags and transported to the CGS lab. Upon completion, the borings were filled with bentonite chips and the locations determined and recorded using GPS. Locations of the borings are shown on Figure 2, Site Map and detailed bore logs are included as Attachment 1 at the back of this report.
