**SOILS, GEOLOGY, AND HYDROLOGY REPORT- RESIDENTIAL DEVELOPMENT**

Madison Avenue SW & 5th Street SW

Bandon, Oregon 97411

CGS Project No. 20111

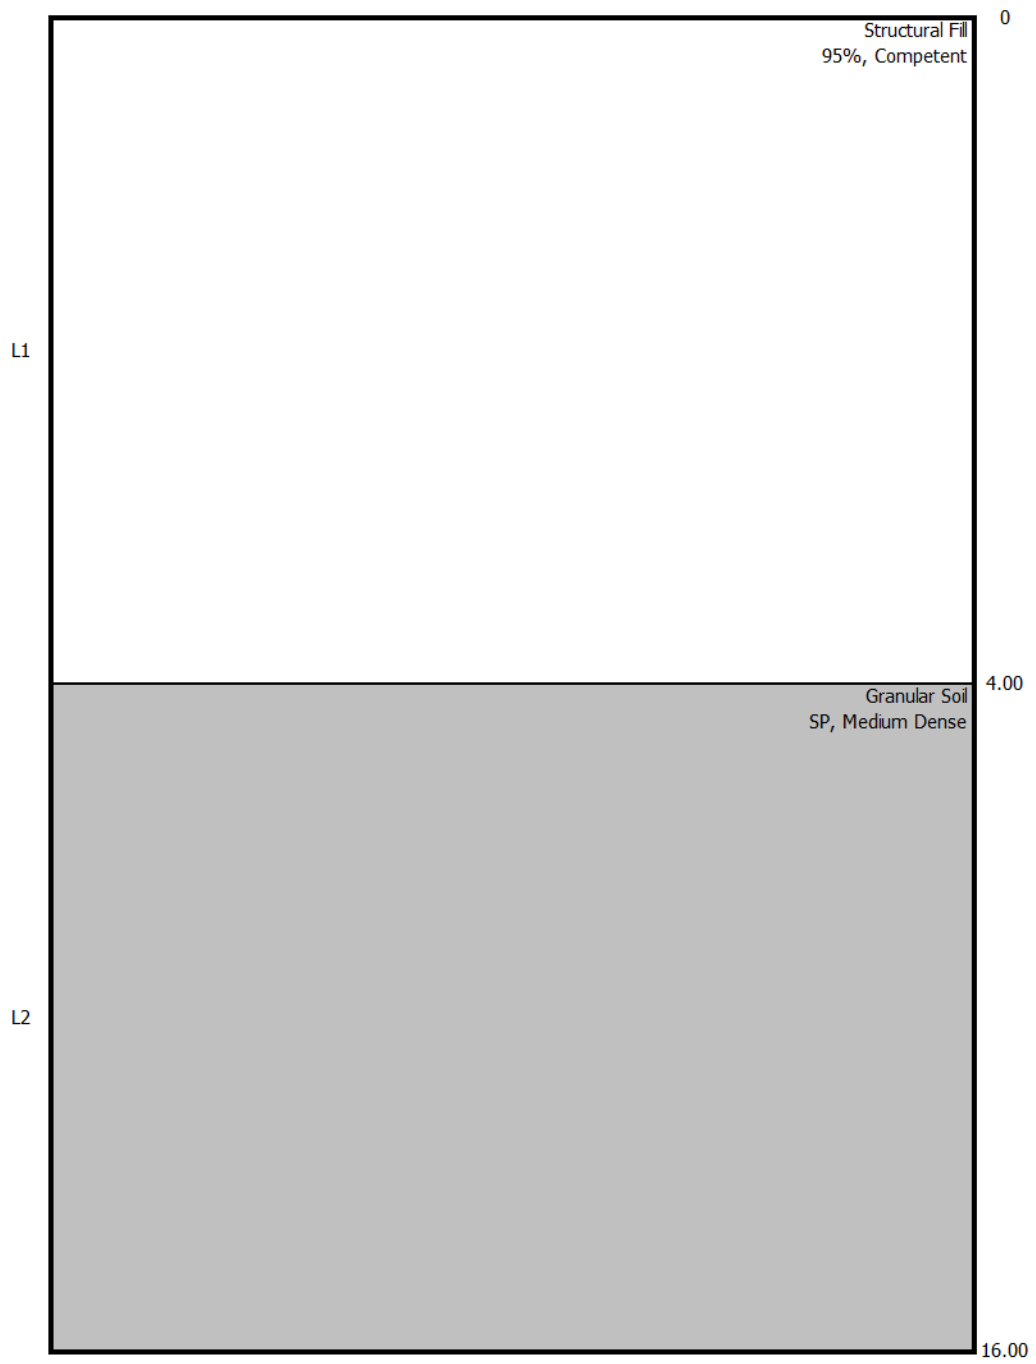
**Fig. 1: Subsurface profile**

### Results

Settlement: 0.51 in  
 Lateral Displacement: 0.00 ft

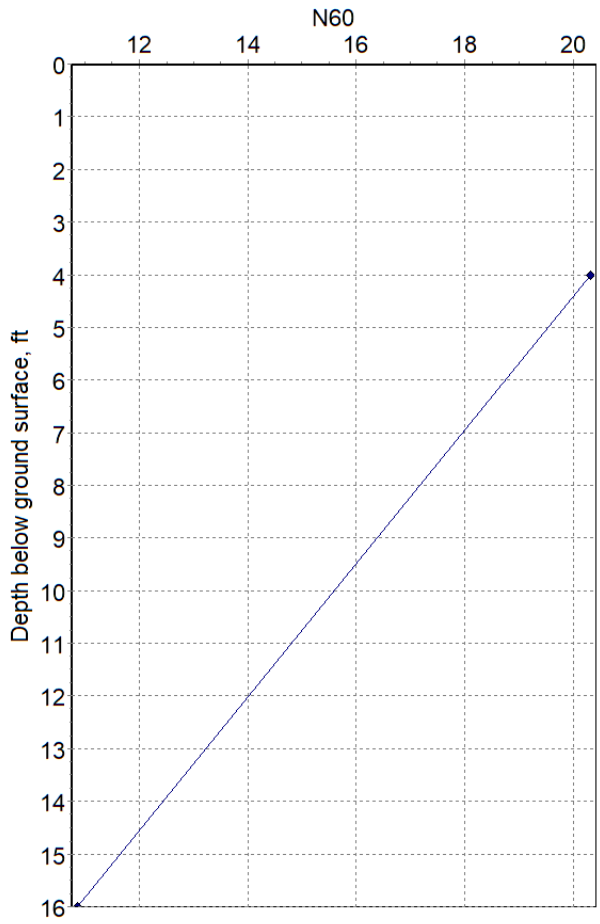
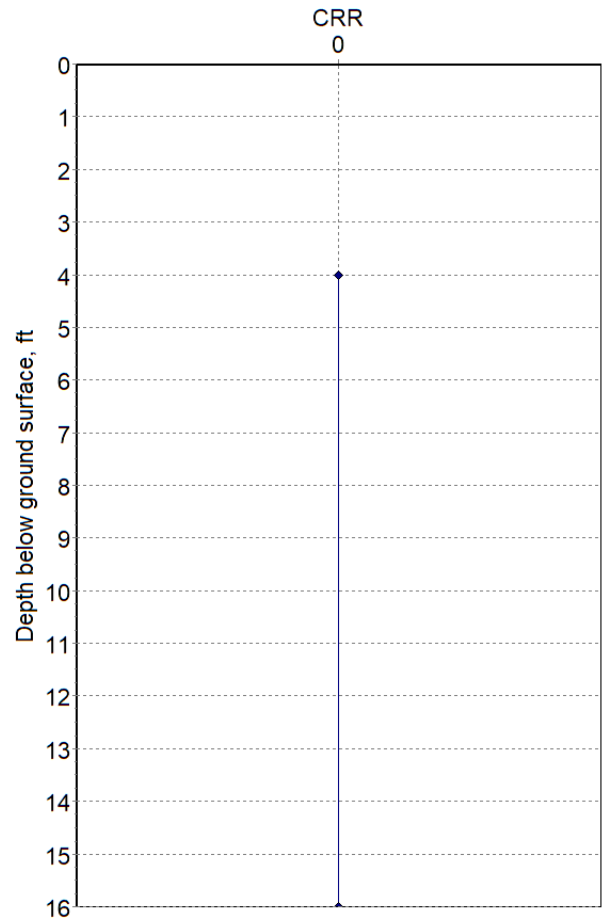
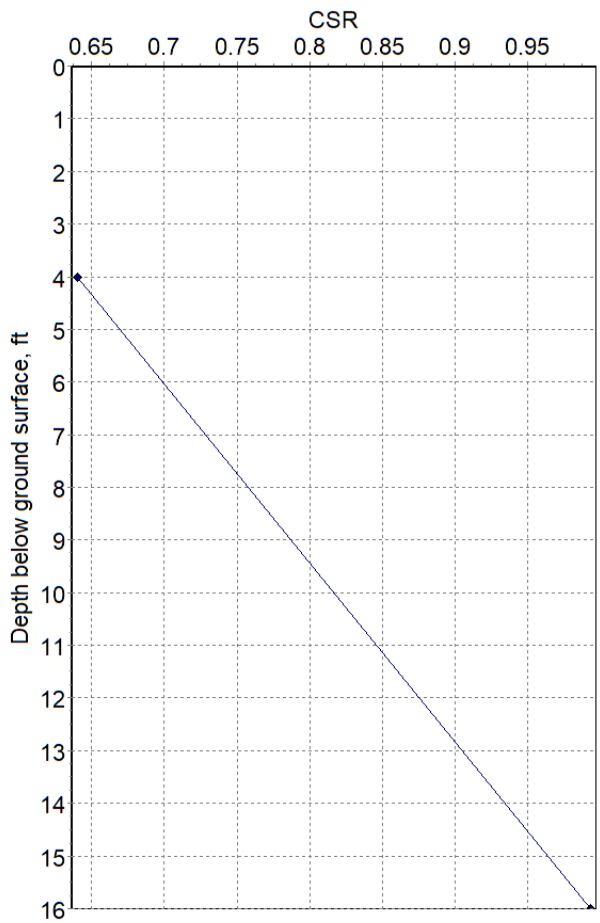
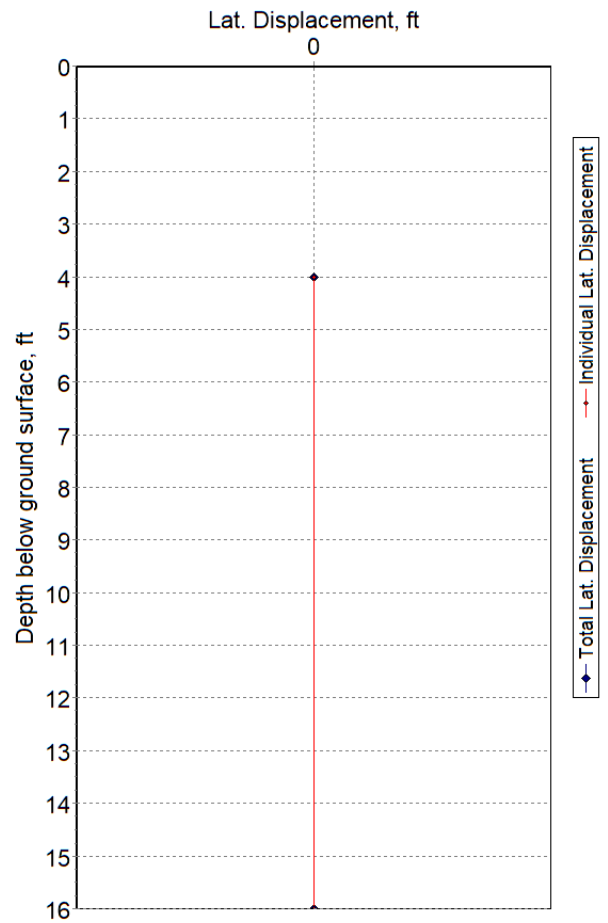
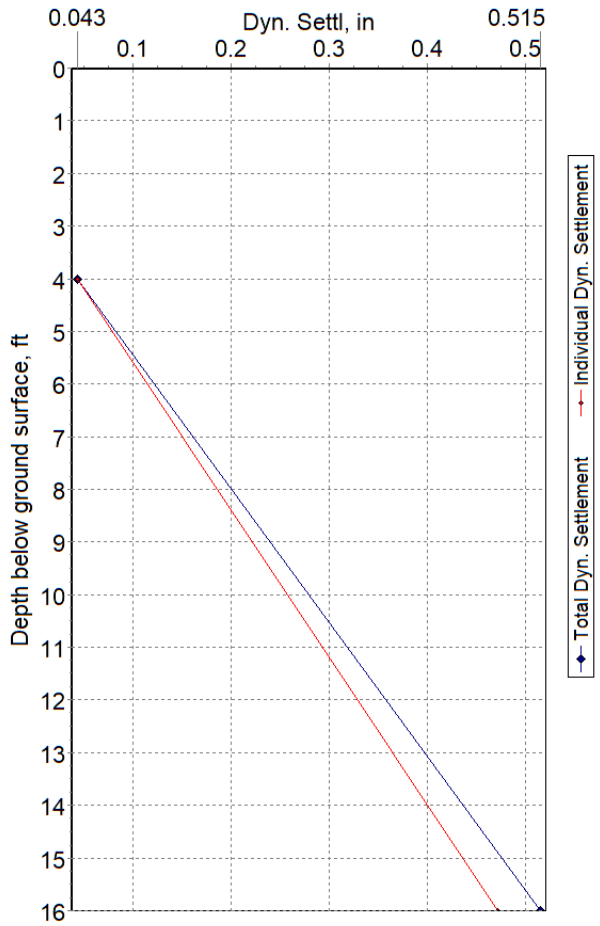
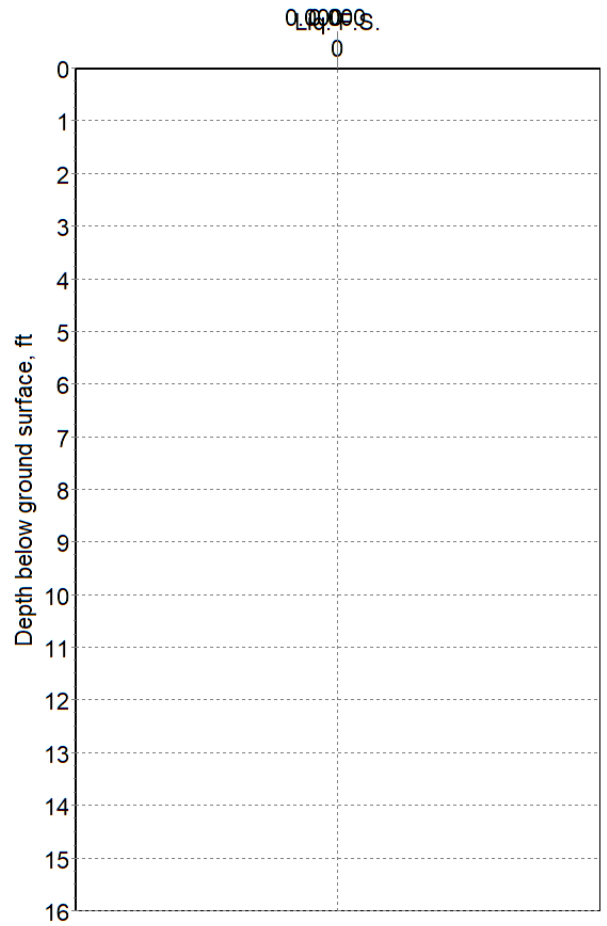
**Liquefaction Analysis - Set 1/4**

**Lateral Displacement**

Sample #	Depth, ft	Max. Shear Str, $\gamma_{max}$	$\Delta H$ I, ft	Lat. Displ. ( $\Delta LD_i$ ), ft	Accum. Lat. Displ, ft
1	4.00	0.000	4.00	0.000	0.000
2	16.00	0.000	12.00	0.000	0.000
