## Technical Memorandum

### Erosion and Sediment Control Plan

1107 6<sup>th</sup> Street Southeast  
Bandon, Oregon 97411

Project No. 959-22001-03

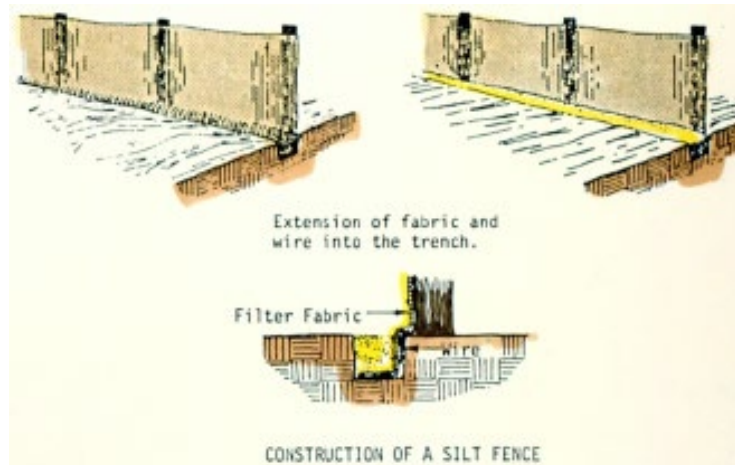
#### Detail 2.1. Silt Fence Detail

Maintenance, such as damage repair or the removal of excessive sediment build up will be carried out as needed.

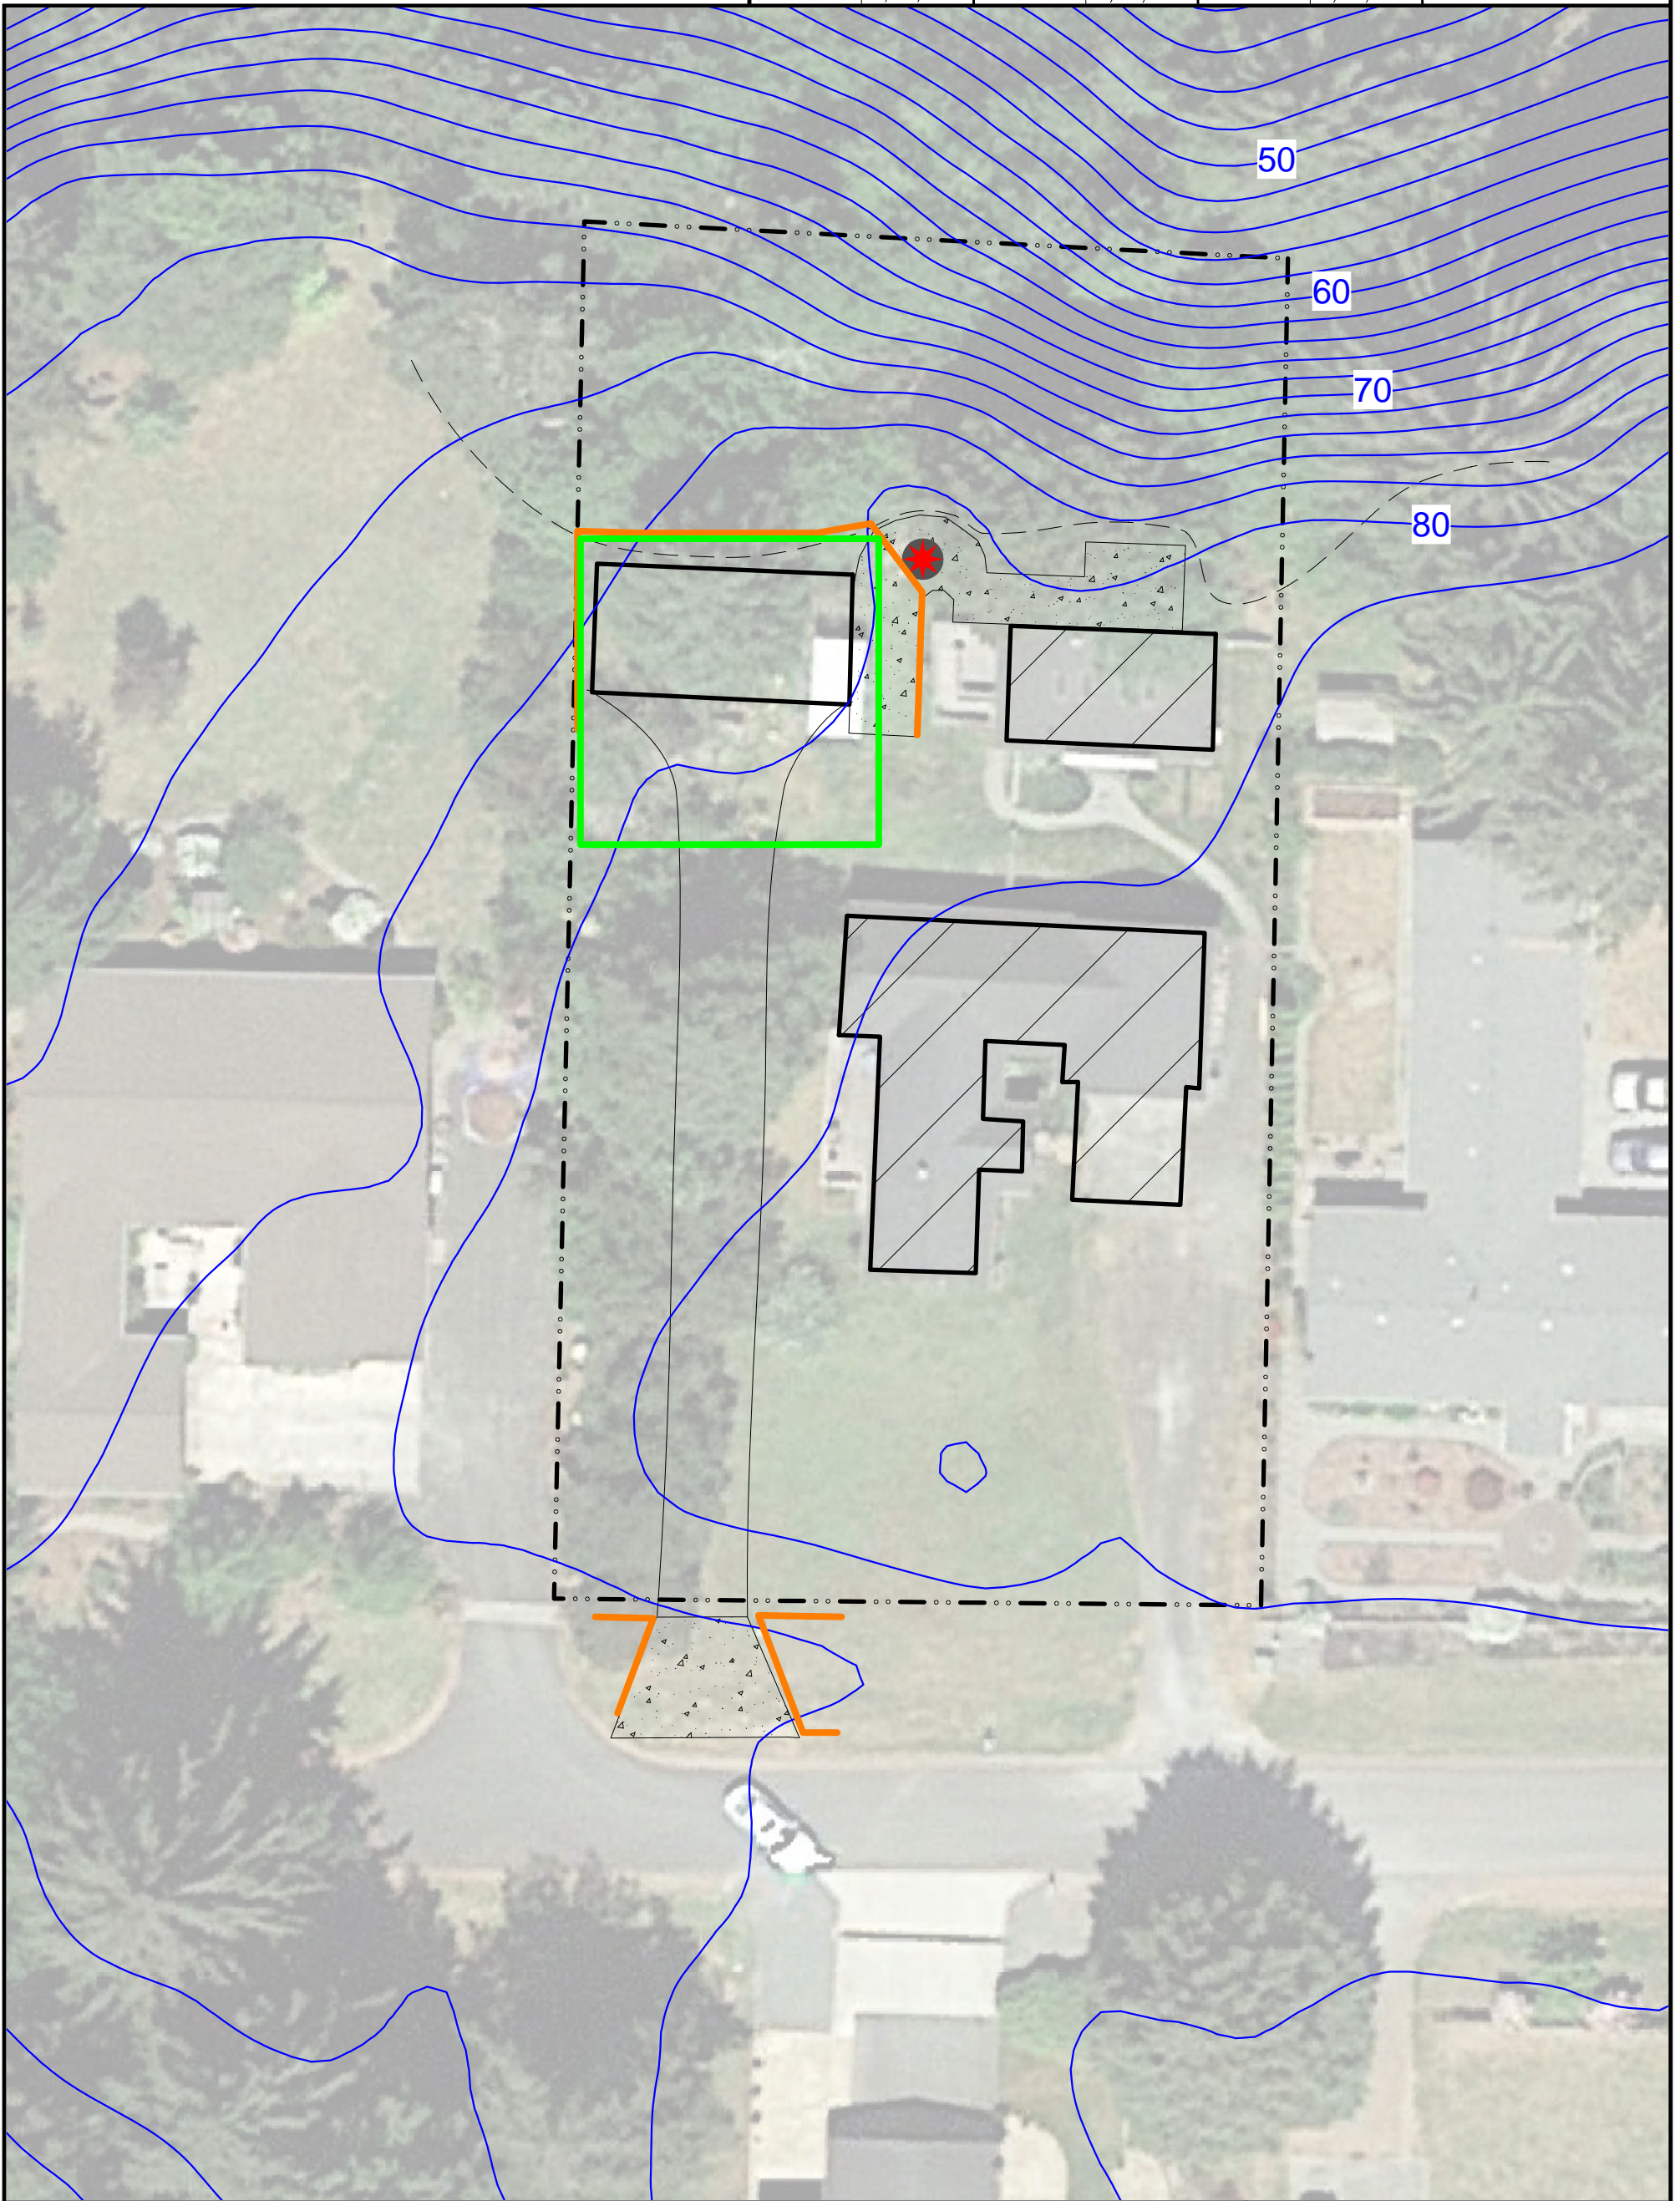
SUBJECT BUILDINGS		NEW CONCRETE
	SUBJECT PROPERTY BOUNDARIES		SILT FENCING
	ESTIMATED 2-FOOT CONTOURS BASED ON SURFACE MODELING USING DOGAMI LIDAR DATA		
	BREAK IN SLOPE		
	FIRE PIT		
	MAXIMUM AREA OF DISTURBANCE

The subject property consists of a developed residential lot that is approximately 200-feet long by 100-feet wide and located in the northeast quarter of the southeast quarter of Section 30, Township 28 south, Range 14 west of the Willamette Meridian in Bandon, Oregon (Figures 1 and 2). It is bordered on the east and west by lots developed with single family residences, on the south by 6<sup>th</sup> Street SE, and on the north by the undeveloped drainage corridor of Ferry Creek (see Figures 2 and 3). The subject property is currently developed with a single-story rental home with attached garage situated on east-central portion of the lot and a smaller studio located approximately twenty-five feet behind (north of) the rental home. A driveway on the eastern edge of the property serves the rental home, and a driveway on the western edge serves the studio. The proposed garage is to be located at the north end of the western driveway and west of the studio. The portion of the lot to the south of the rental home is lawn and the portion north of the studio is woodland (see Figure 3 and photographs in Appendix A).

As noted above, no surface water features are located in or immediately adjacent to the proposed building site. It is anticipated that most storm water runoff from the building area will be as un-channelized sheet runoff to the north. Any sediment being transported by such runoff should be captured by the sediment fence discussed above. However, to protect channelized storm water flow in the ditch along 6<sup>th</sup> Street SE, additional sediment fencing will be installed along the east and west margins of the driveway apron from 6<sup>th</sup> Street (see Figure 3).
