Planning Permit Application

I. PROJECT LOCATION			
Street Address: 1880 Beach Loop			
Map Number / Tax Lot(s): 28-15-36BC	/ 1400	Zone: CD-1	Floodplain: <input type="checkbox"/> Yes <input checked="" type="checkbox"/> No

Geotechnical Engineering Report

VICINITY MAP
 Geotechnical Site Investigation
 Schoenbrun Residence
 TL 1880 Map 28S-15W-36BC; Beach Lp. Dr., Bandon, OR

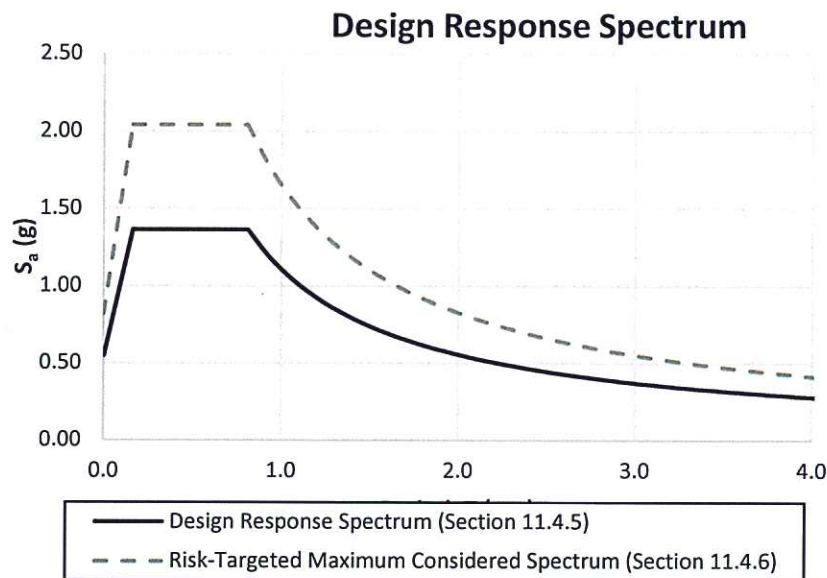
Figure 2- Design Response Spectrum for Site Class D

Based on the observed subsurface soil conditions and criteria in ASCE 7-16, we recommend that a seismic site class is “D – Stiff Soil” is appropriate for this site.
